## Hunter Valley Operations

### 2015 Annual Environmental Review

March 2016

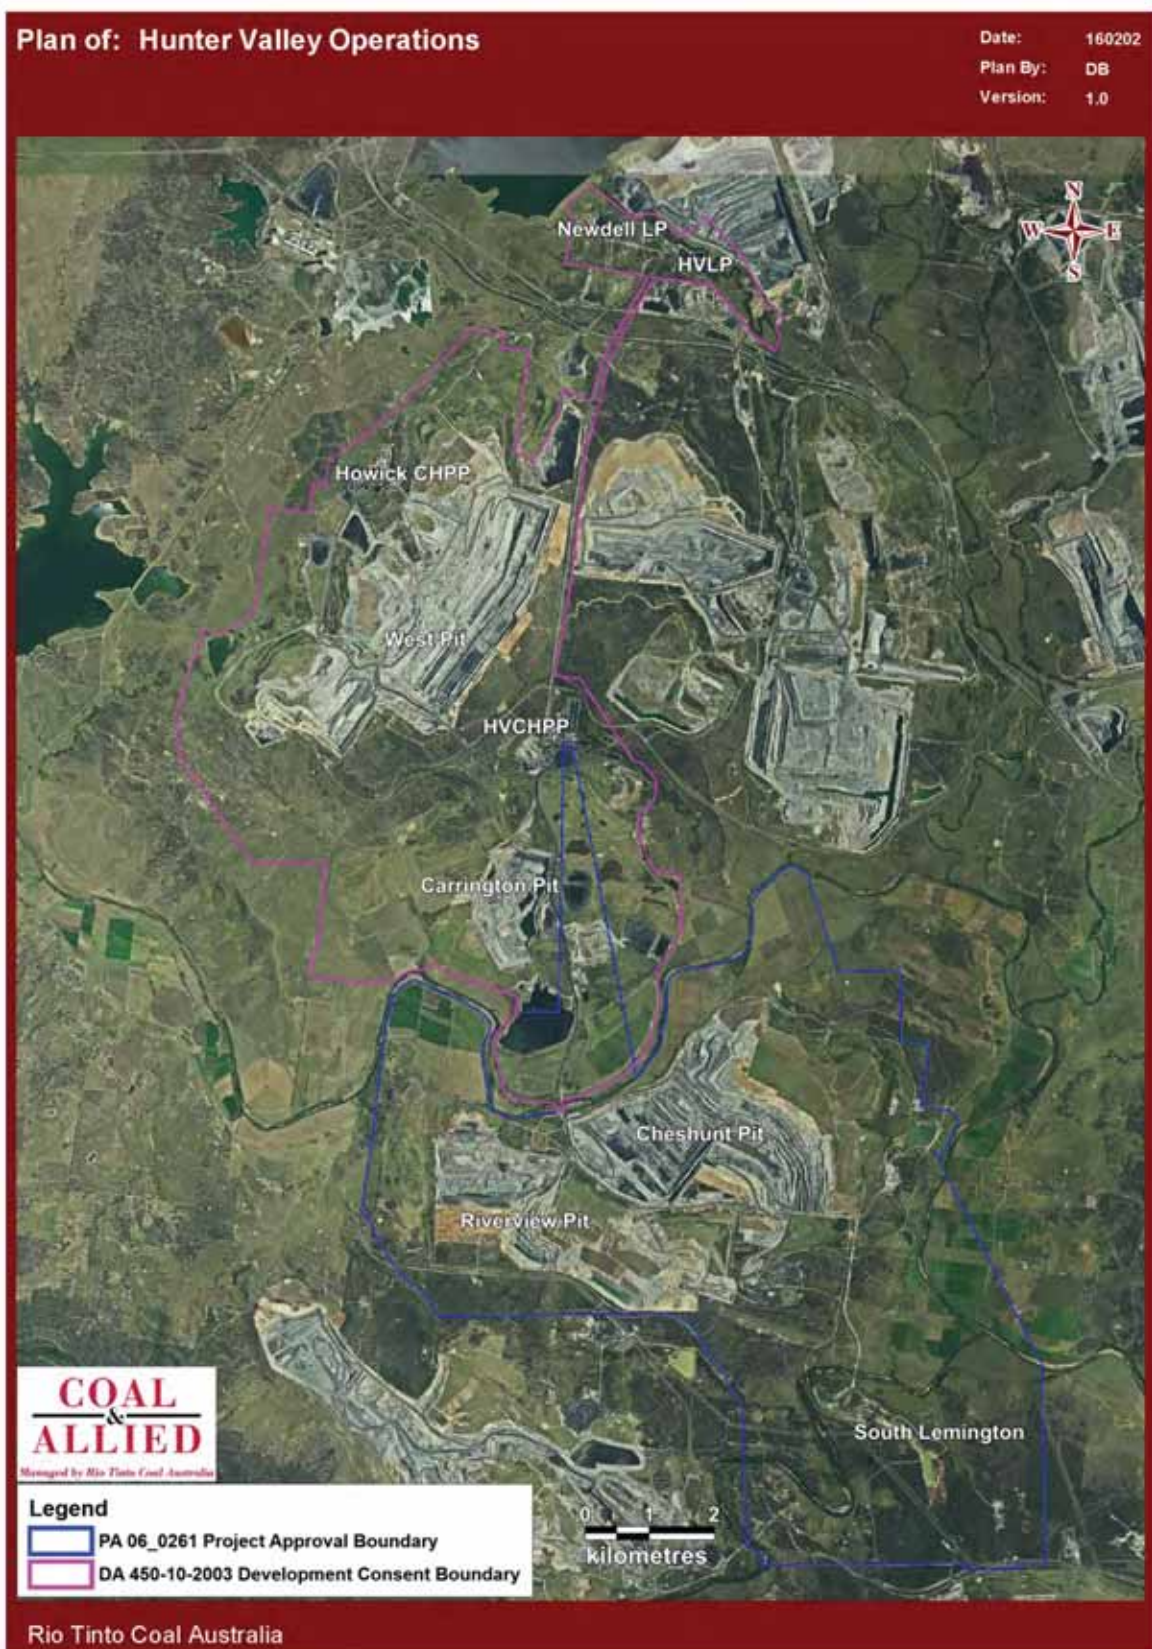
Figure 1: Hunter Valley Operations - Site Layout

The layout of the HVO pits and facilities is shown in Figure 1.

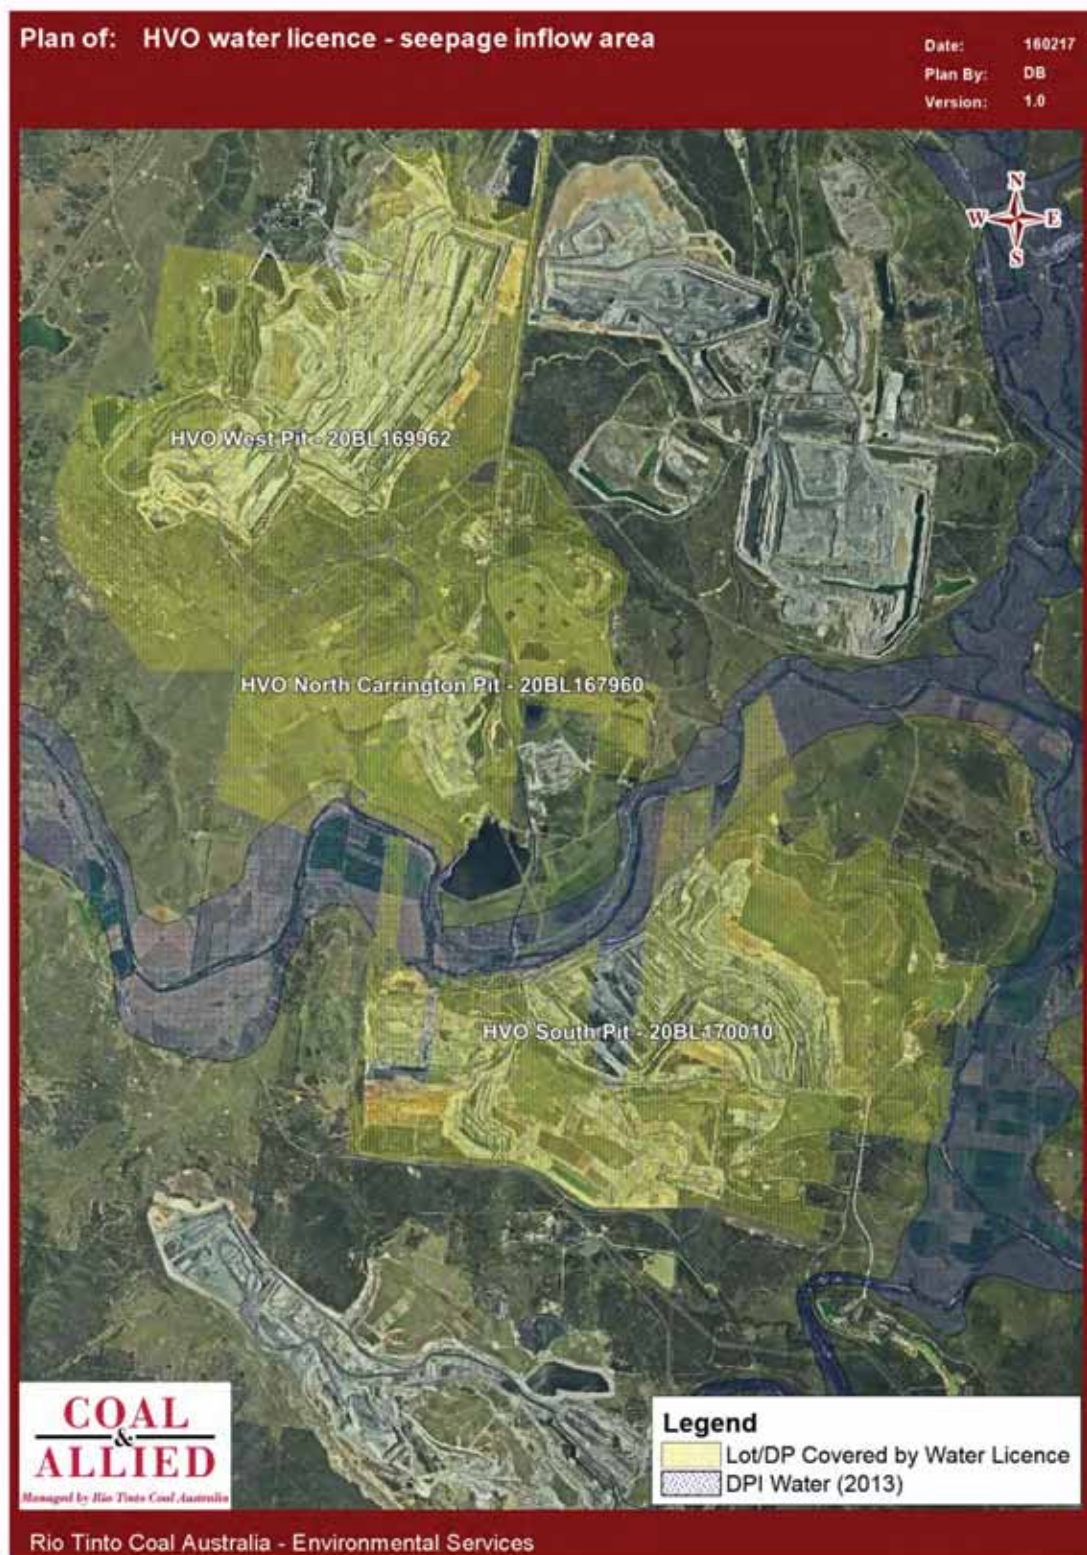
Figure 30: HVO Water Licence - Seepage inflow area

<b>Water Licence #</b>	<b>Water Sharing Plan, source and management zone</b>	<b>Entitlement Units (ML/a)</b>	<b>Passive take/inflows (ML/a)</b>	<b>Active pumping (ML/a)</b>	<b>Total (ML/a)</b>
WAL962 HVO North	Hunter Regulated River WSP, Hunter Regulated River Water Source, Zone 1B	3,165	84	0	84
WAL970 HVO South	Hunter Regulated River WSP, Hunter Regulated River Water Source, Zone 2A	500	430.7	0	430.7
WAL1006 HVO South	Hunter Regulated River WSP, Hunter Regulated River Water Source, Zone 2A	500	430.7	0	430.7
WAL1070 HVO South	Hunter Regulated River WSP, Hunter Regulated River Water Source, Zone 2A	500	0	0	0
20BL167860 HVO North Carrington Pit	Part 5 Water Act 1912	220	7.3	0	7.3
20BL169962 HVO West Pit	Part 5 Water Act 1912	180	175	0	175
20BL170010 HVO South Pit	Part 5 Water Act 1912	350	51.1	0	51.1

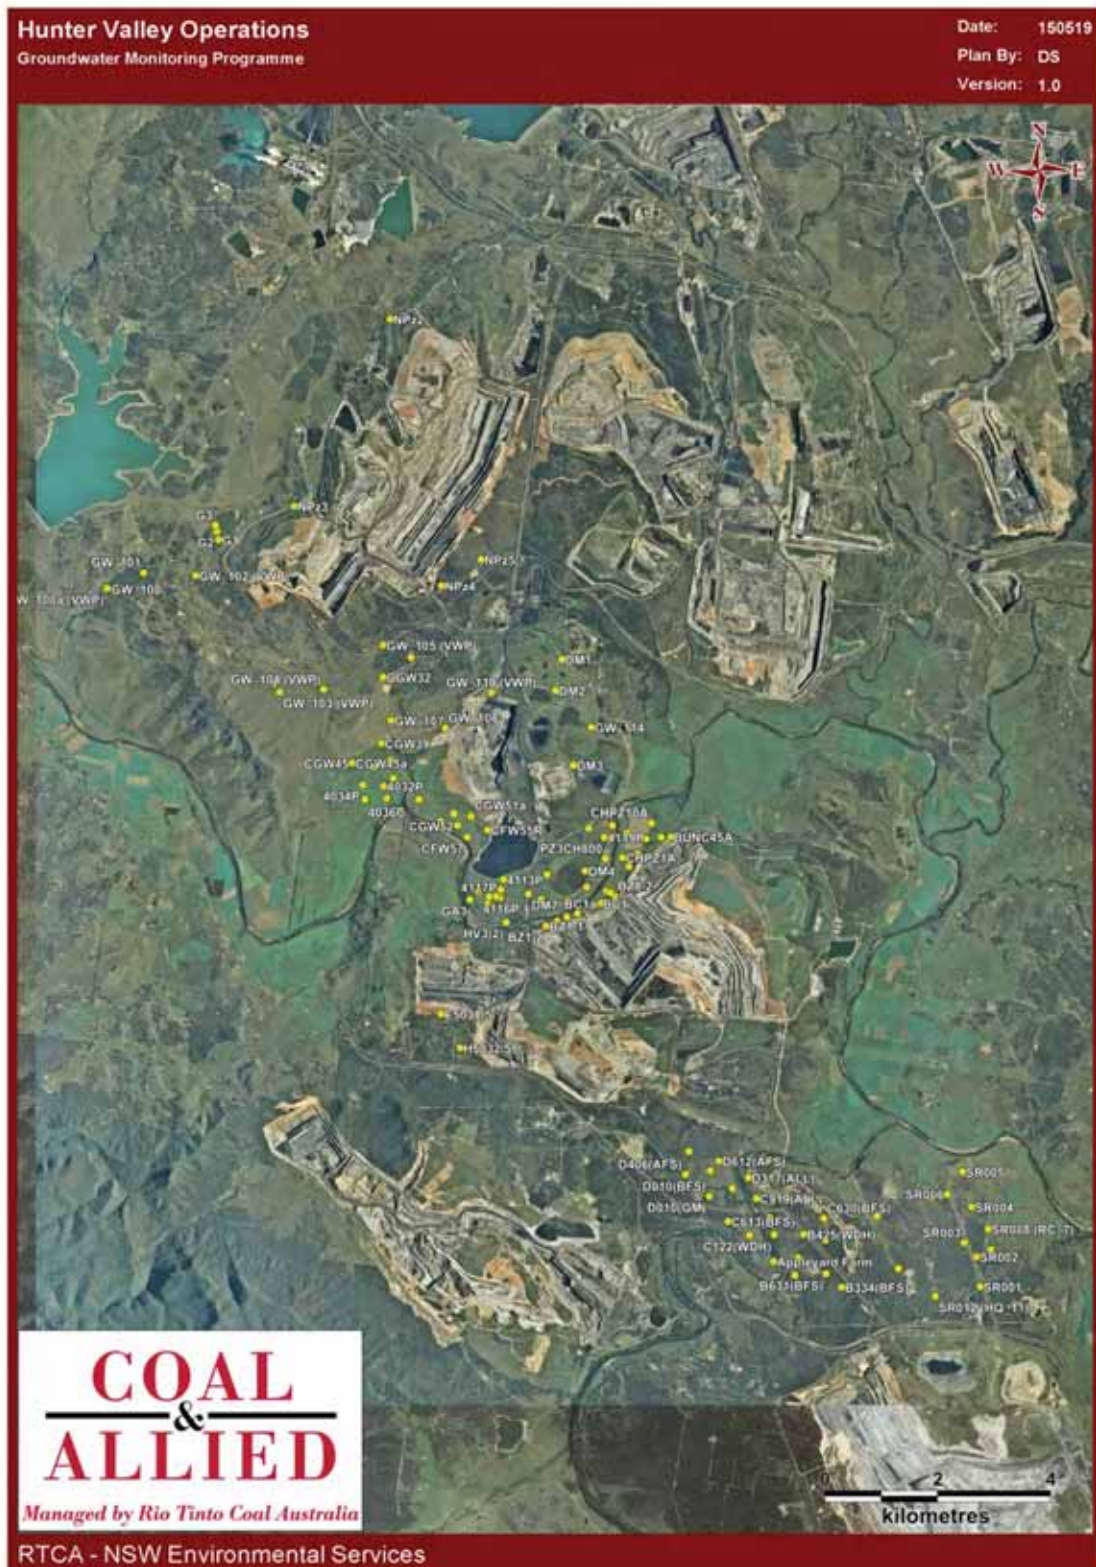
Figure 44: Groundwater Monitoring Network at HVO - 2015

Groundwater monitoring data is reviewed on a quarterly basis. The review involves a comparison of measured pH and EC results against internal trigger values which have been derived from the historical data set. Trigger limits are calculated as the 95th percentile maximum value (EC and pH) and the 5th percentile minimum value (pH only) from data collected since 2011. Trigger levels have been set on the basis of geographical proximity and target stratigraphy. Bores that record as dry and bores of unknown seam have not been included in calculation of the trigger limits. The response to measured excursions outside the trigger limits is detailed in the HVO Water Management Plan. Where investigations and subsequent actions have been undertaken following review of monitoring data, these are detailed in this section. Monitoring locations are shown in Figure 44.

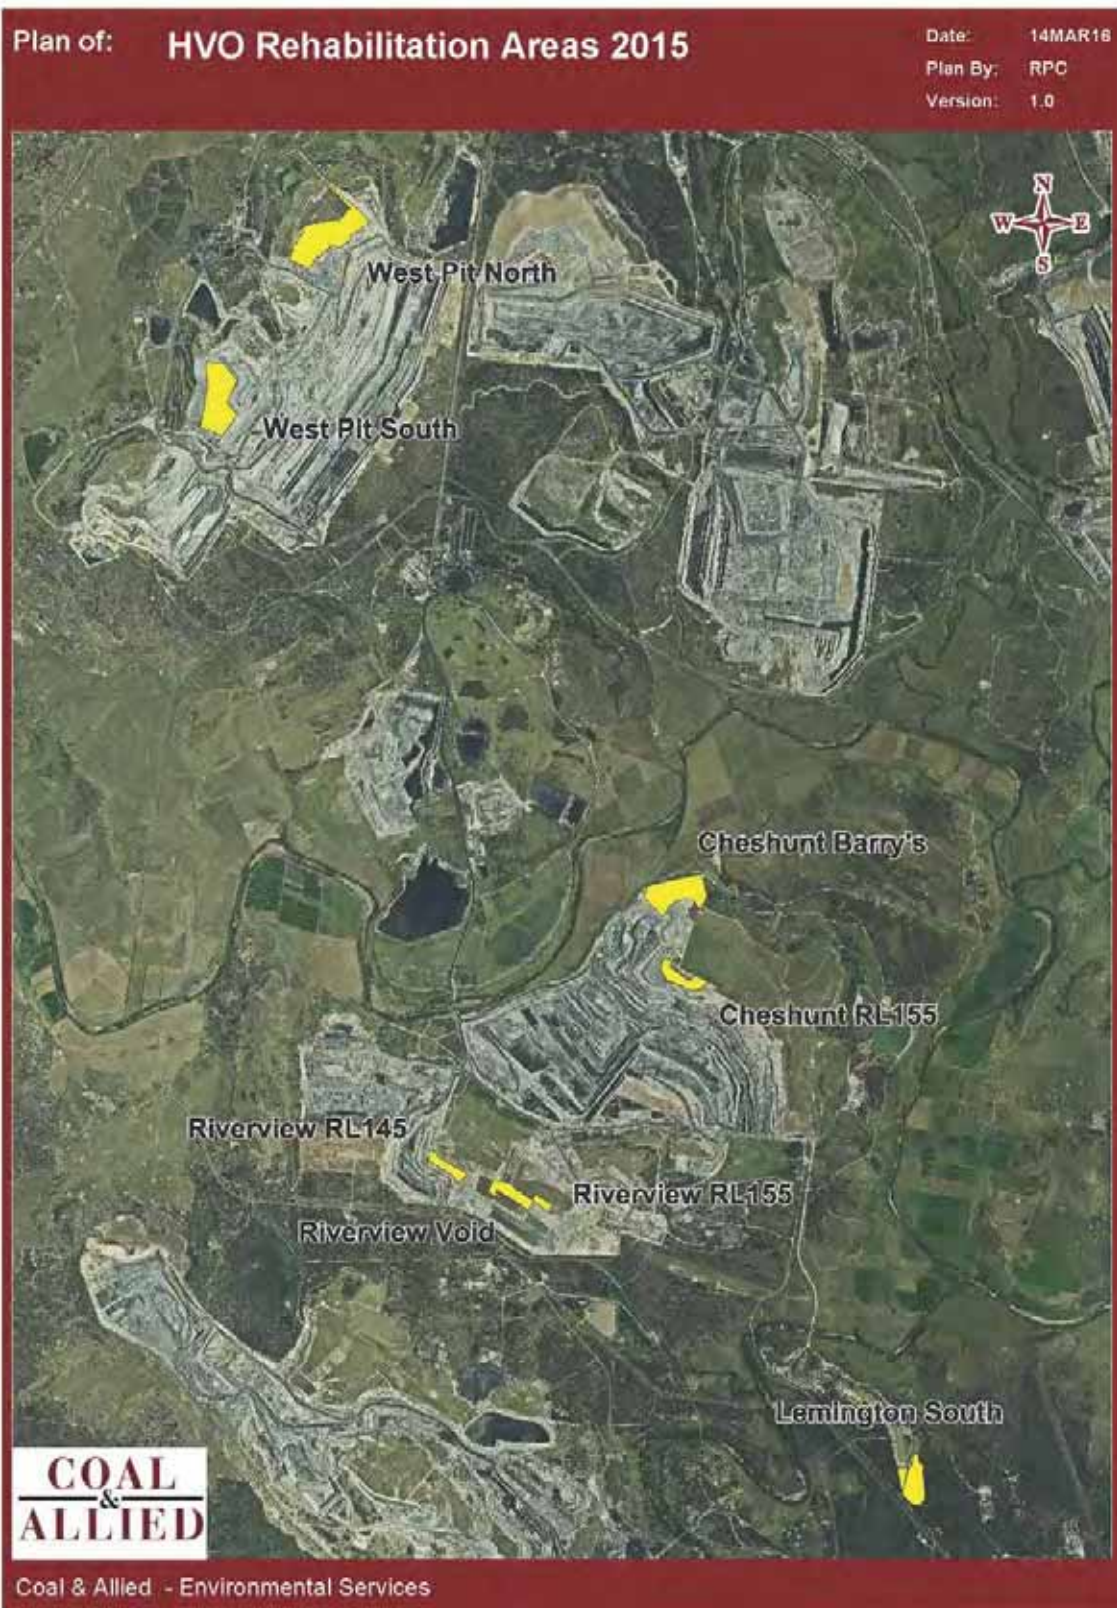
Figure 98: HVO Rehabilitation areas - 2015

A licence agreement is in place for grazing 719 ha of HVO North rehabilitation area. Temporary grazing licences aimed at reducing fuel loads are in place for a further 212 ha of rehabilitated land across HVO North.

During 2015, a weed wiper was trialled in rehabilitation areas to enable taller growing weeds to be selectively targeted with herbicide. The weed wiper was found to be effective at removing quick-growing exotic grass species (ie Rhodes Grass, Green Panic etc.) from areas that had been sown with native seed mixes.

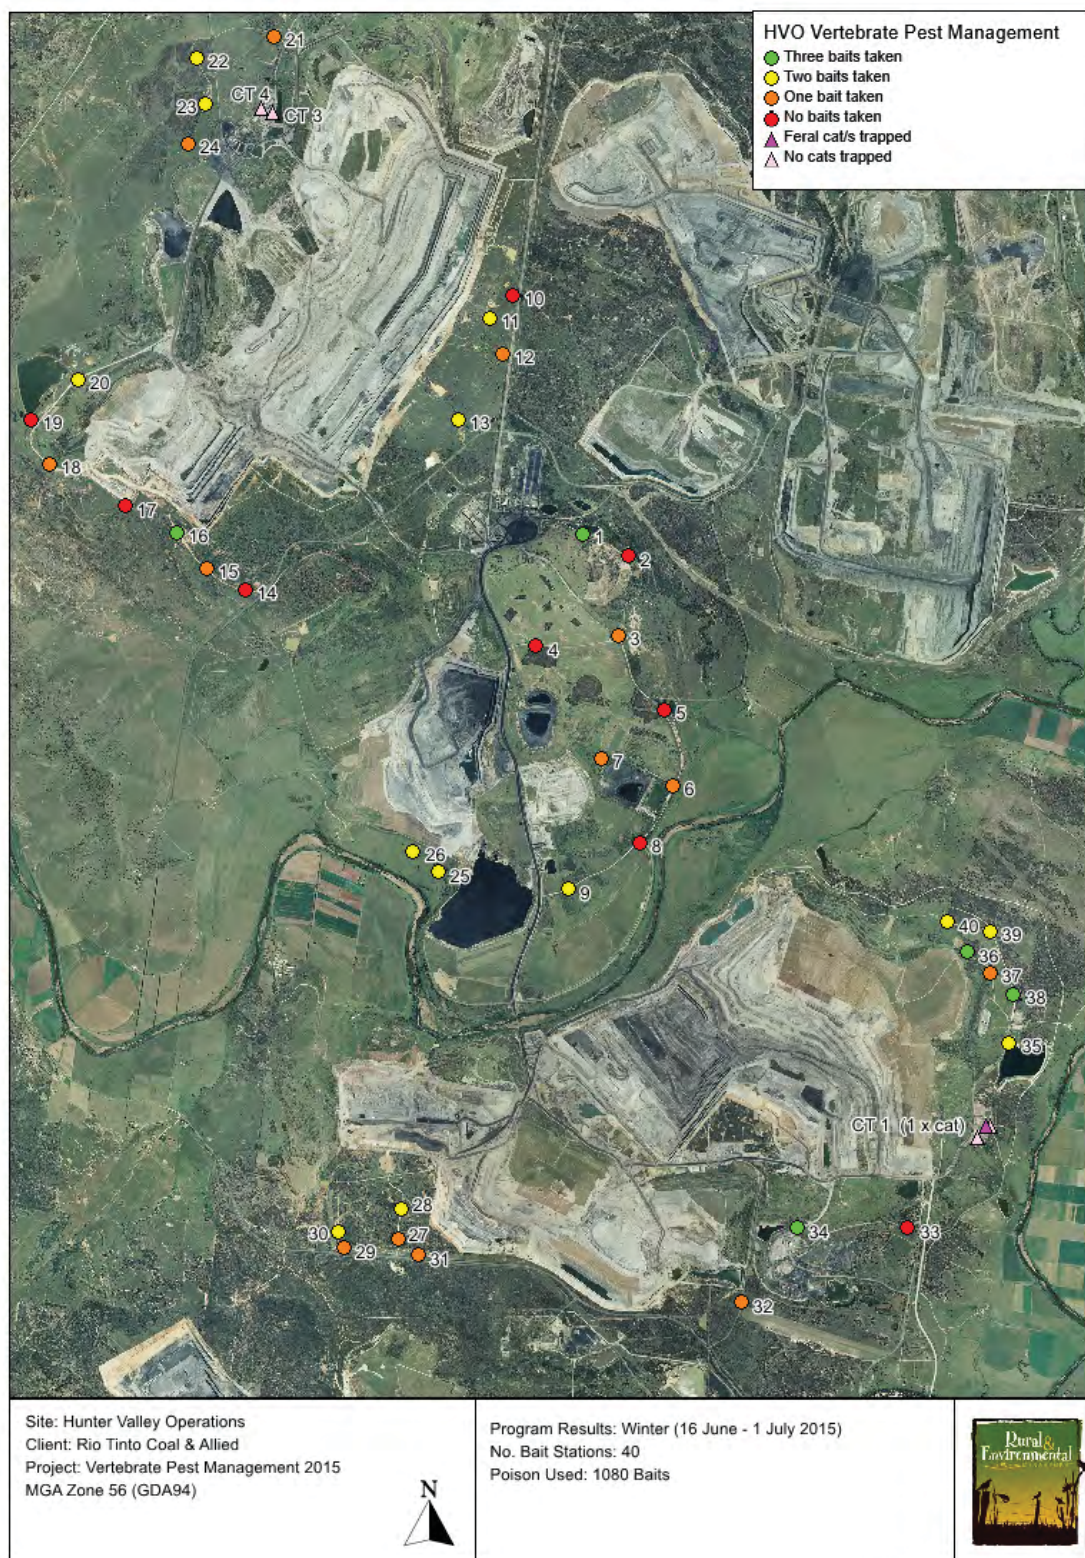
**Figure 103: HVO Vertebrate Pest Management Bait Locations - Winter 2015**

Table 44 summarises the results from the vertebrate management programmes carried out at HVO during 2015 with baiting locations and results for the Winter and Spring program illustrated in Figure 102 and Figure 103 respectively.

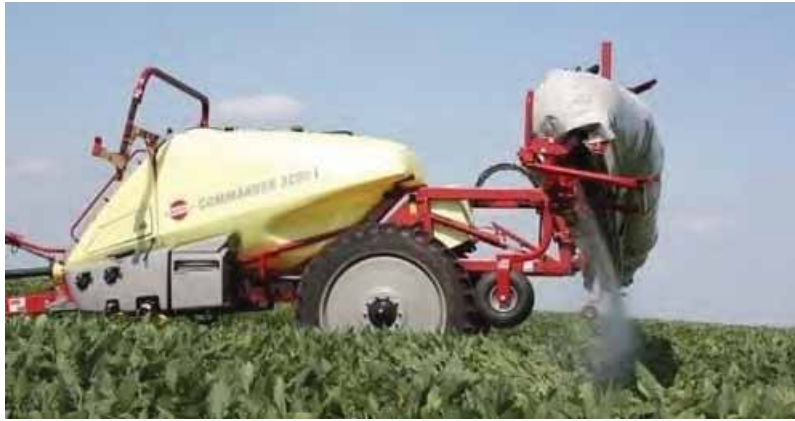
**Figure 110: Spray rig boom fitted with air-assist shroud**

An air-assisted boom sprayer (Figure 110) will be trialled to control weeds on rehabilitation areas and topsoil stockpiles. The spray nozzles are enclosed within a shroud and air is used to direct the herbicide out through the bottom of the shroud and onto the target weeds. The air-assist design helps to minimise spray drift onto off-target areas and results in better leaf coverage with herbicide for a more effective kill of target species.

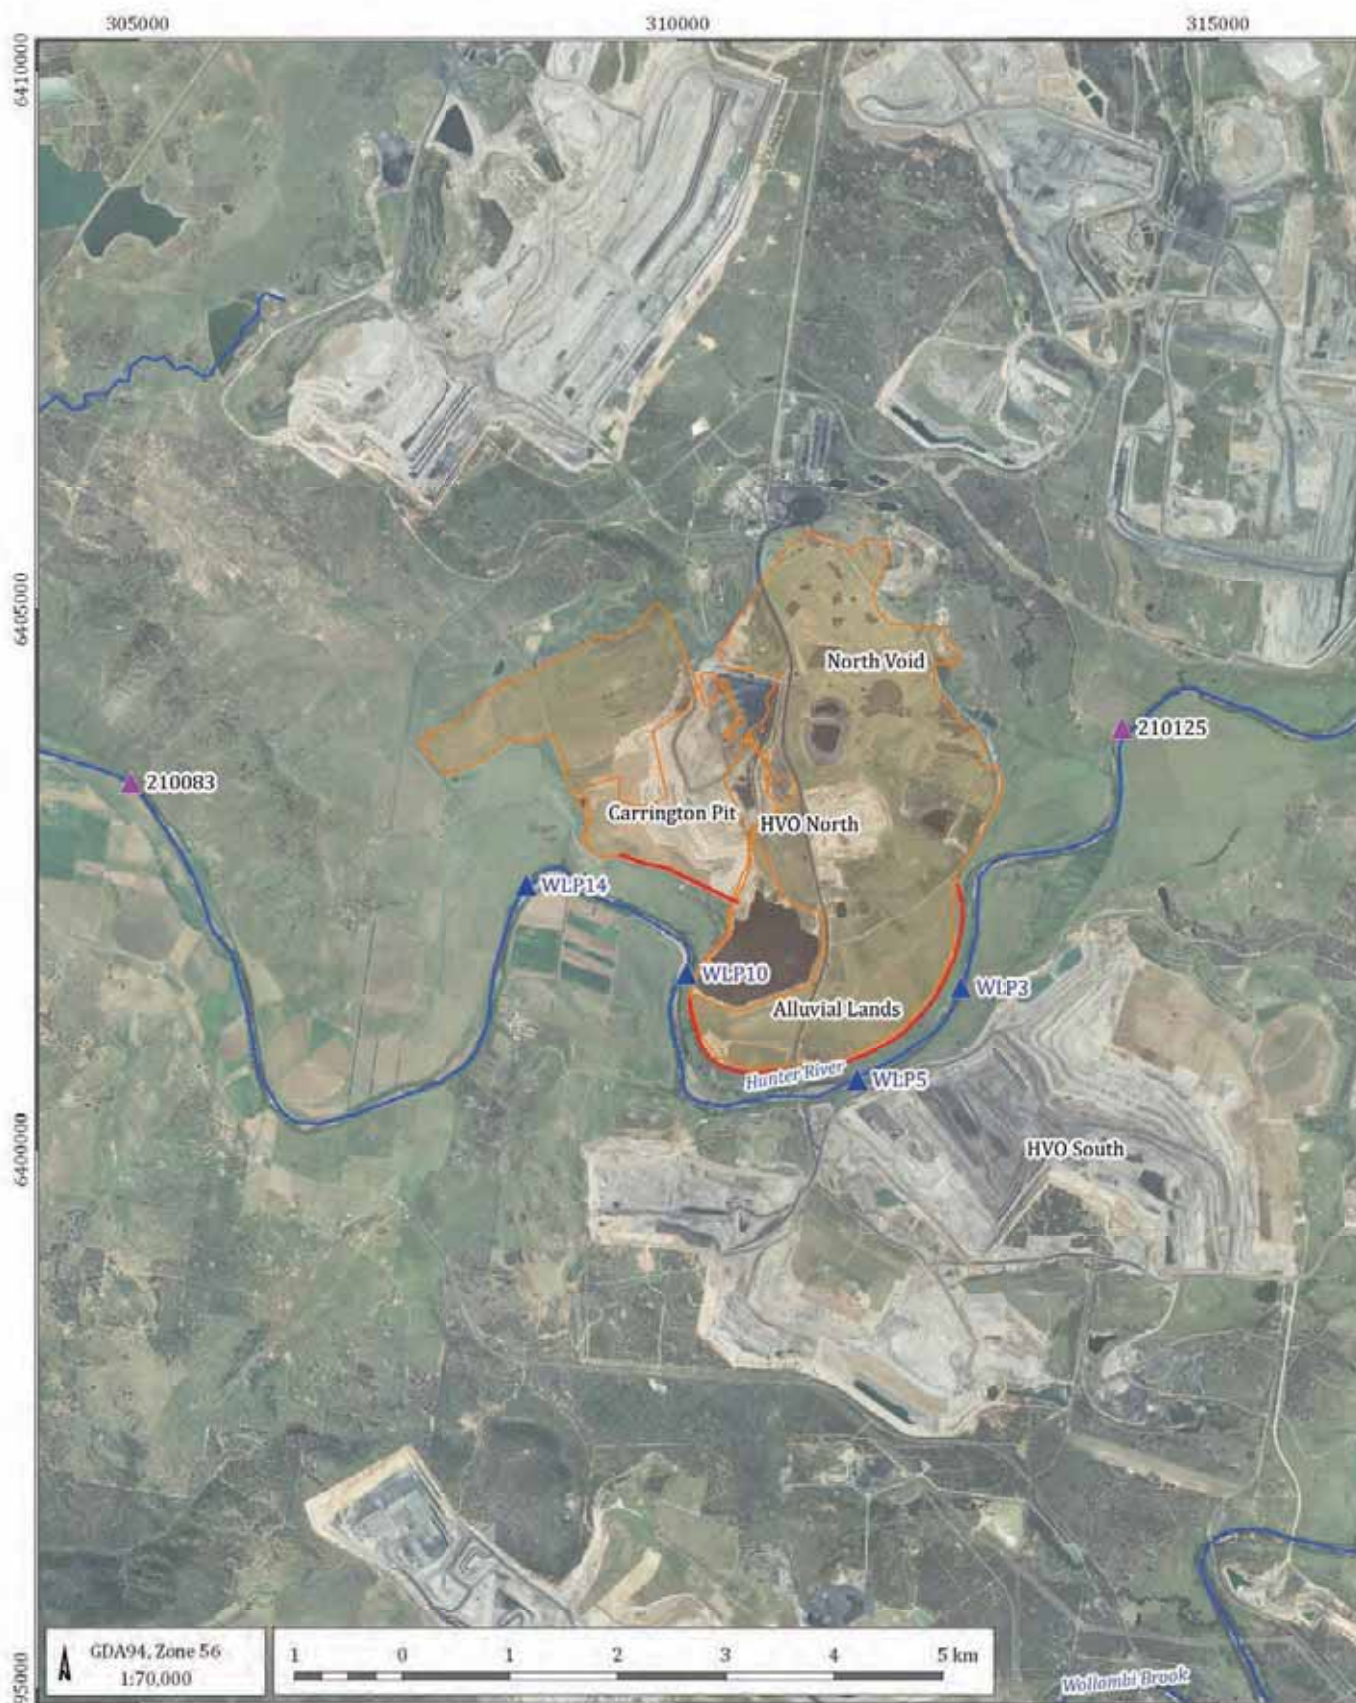
The barrier wall was constructed as a compacted clay buttress wall, against an existing levee that extended across the eastern limb of a Tertiary palaeochannel. The wall was constructed to the base of the Vaux Seam. The extent of the barrier wall and the location of the Carrington Billabong are shown in Figure 1.

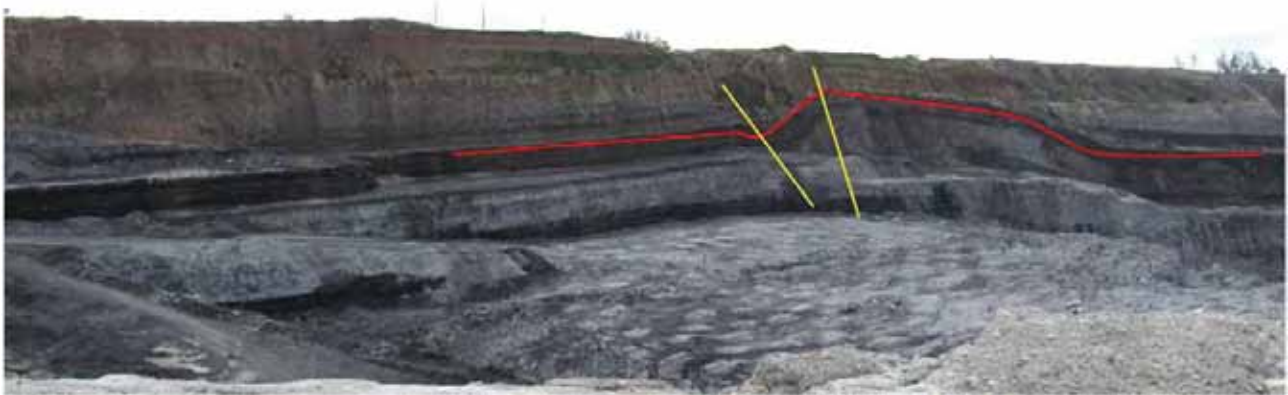
**Figure 5 Cheshunt Pit anticline**

An anticlinal structure is also present within the northern highwall of Cheshunt Pit. Figure 5 highlights the anticline (in red), and shows minor displacement of the coal measures along minor faults (in yellow). Along the crest of the anticline, the Mount Arthur Coal Seam appears to sub-crop beneath the alluvium (MER 2005).

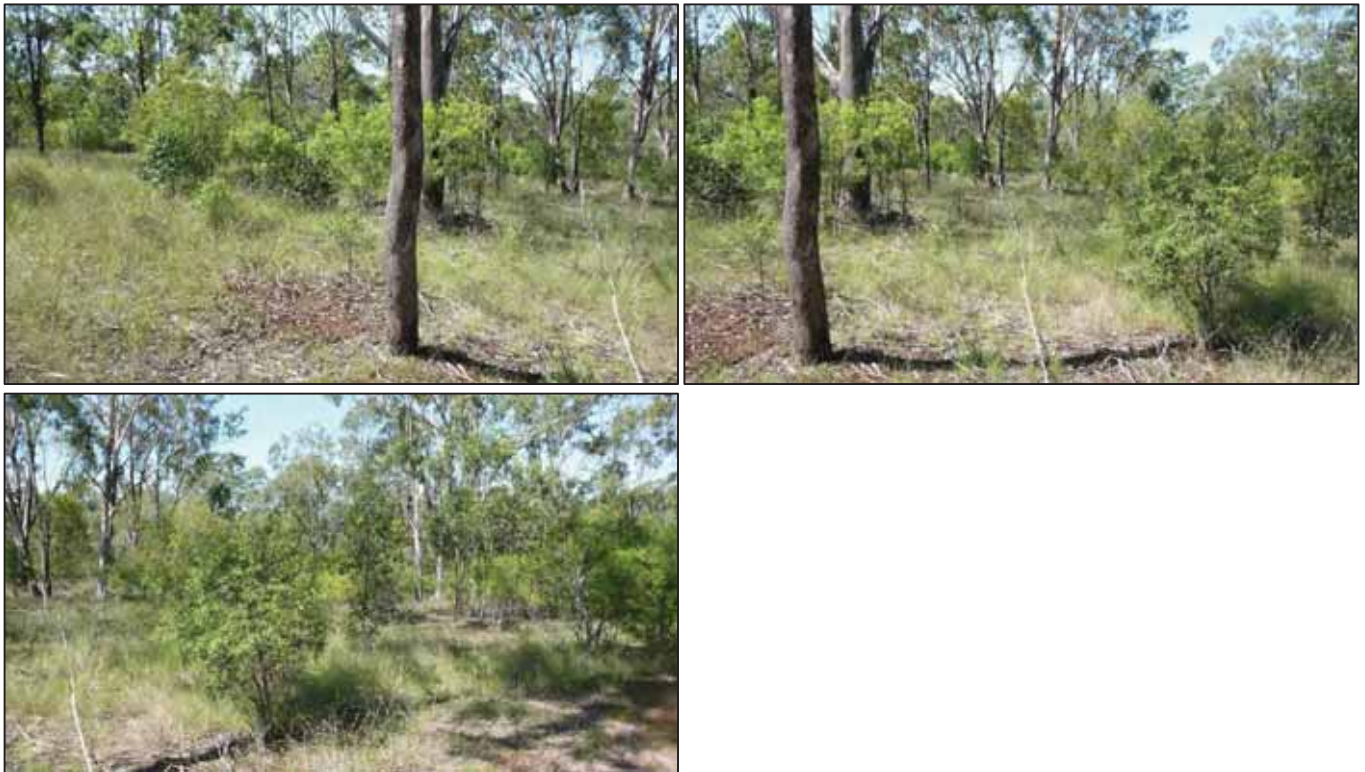
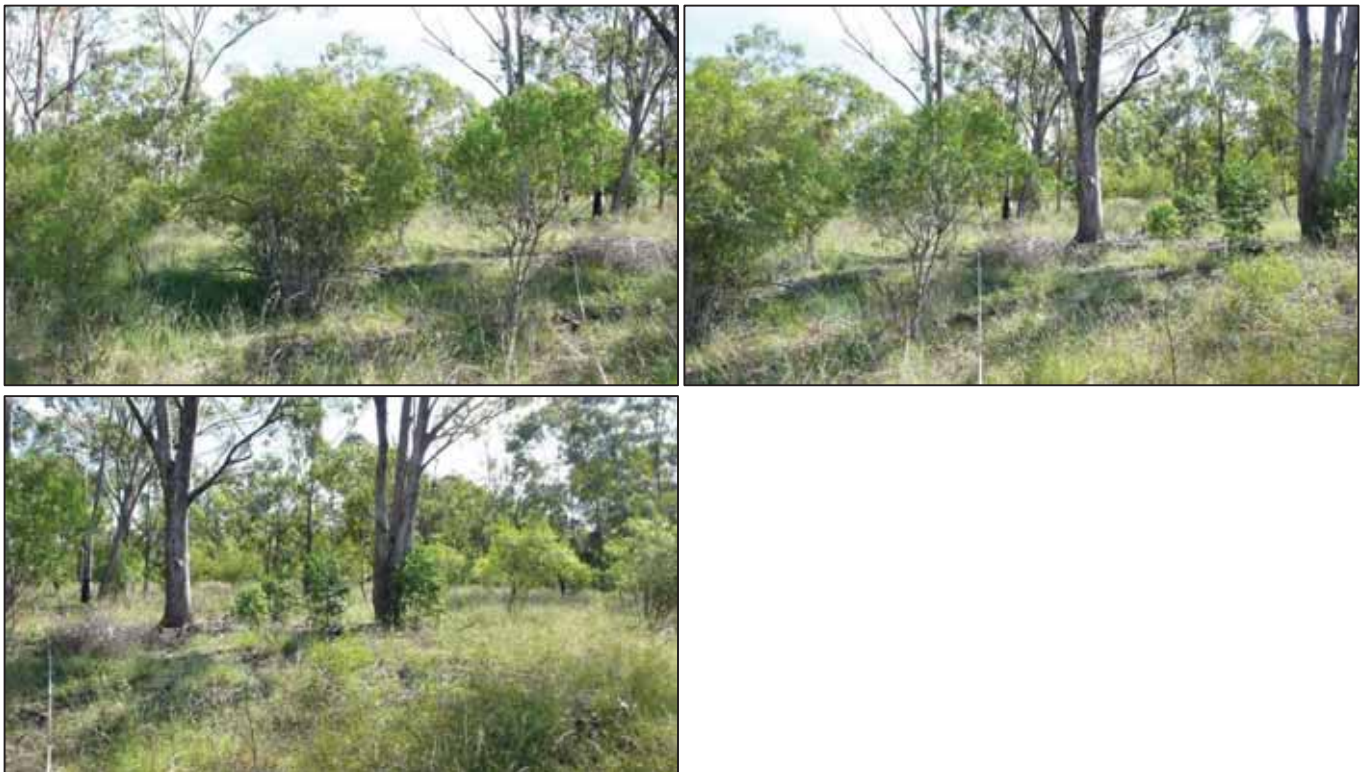
## Site photographs at Wambo Grey Box 02 (left to right)

No damage from fire activity was observed at the site.

No access tracks, or evidence of trail bikes or foot traffic was observed at the site.

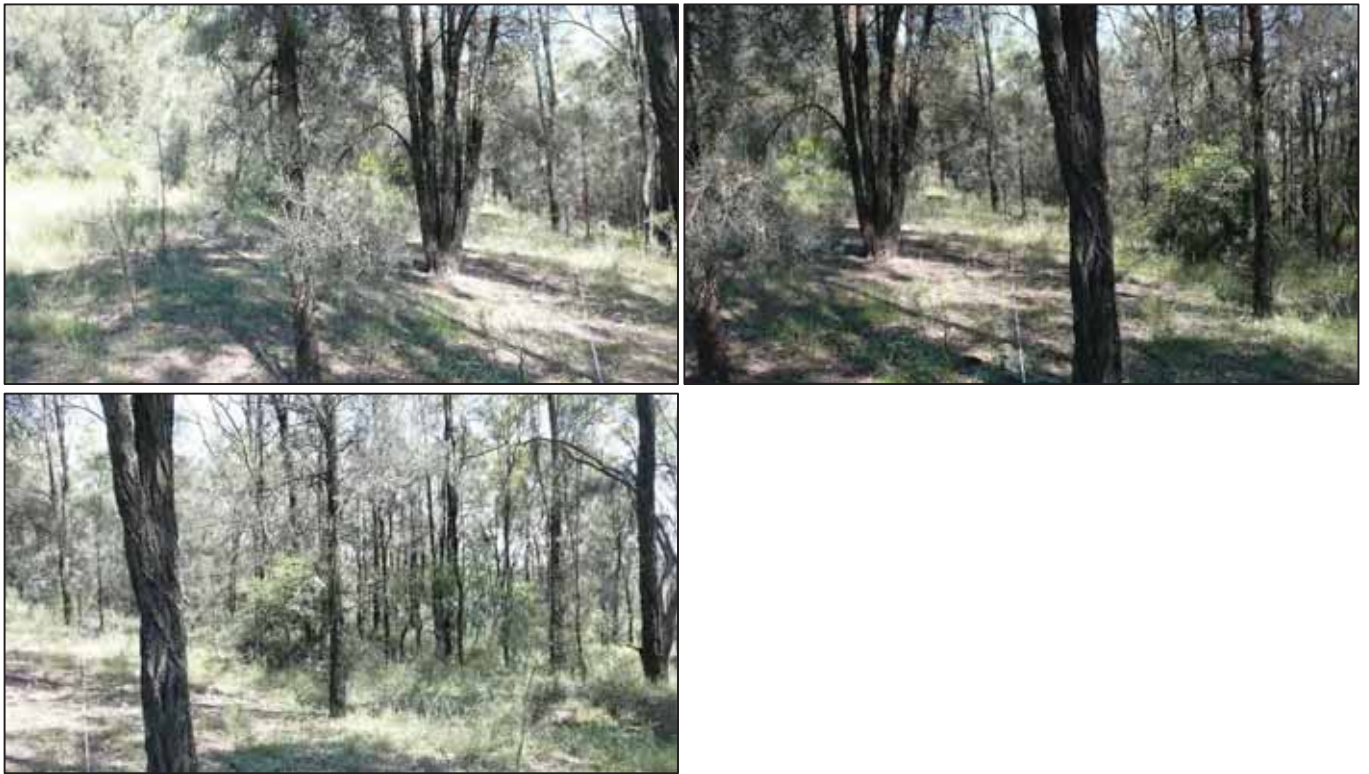
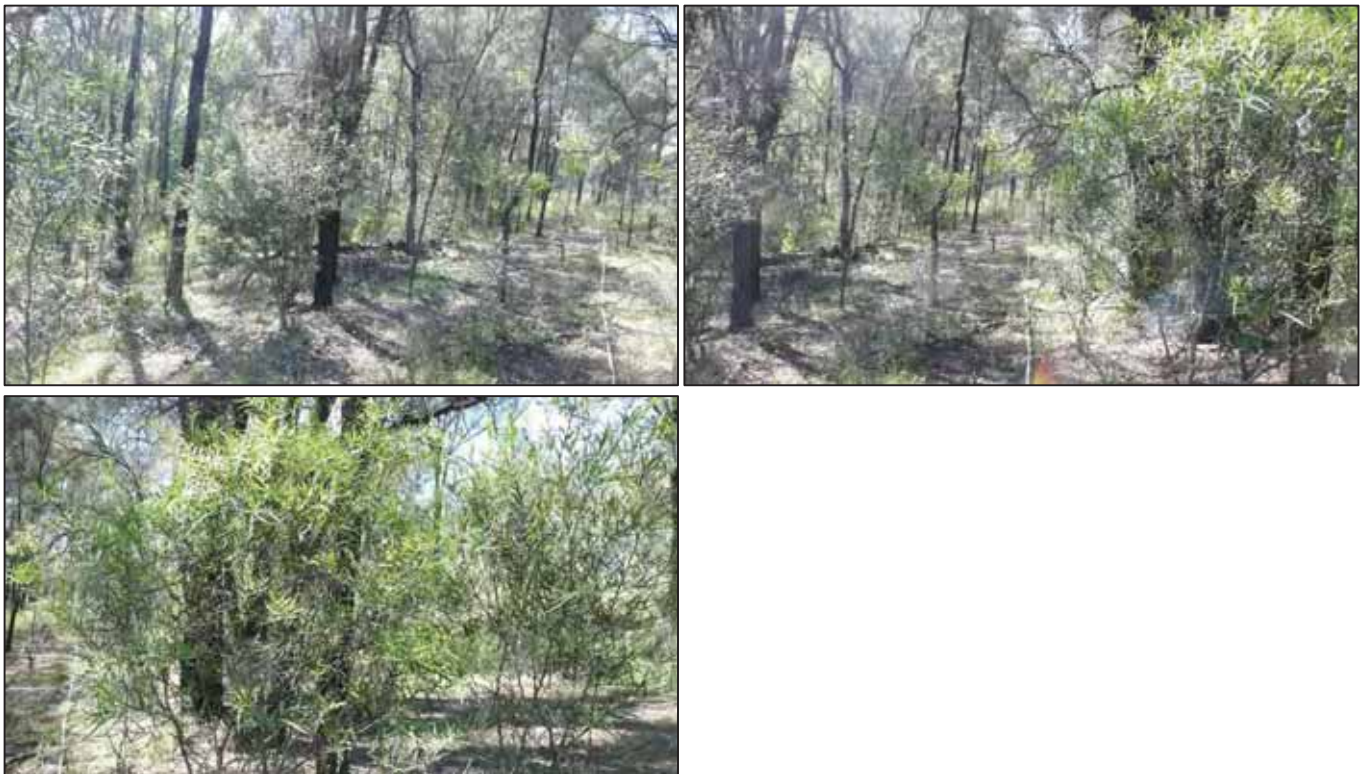
## Site photographs at Warkworth Grey Box 01 (left to right)

No damage from fire activity was observed at the site.

No access tracks, or evidence of trail bikes or foot traffic was observed at the site.

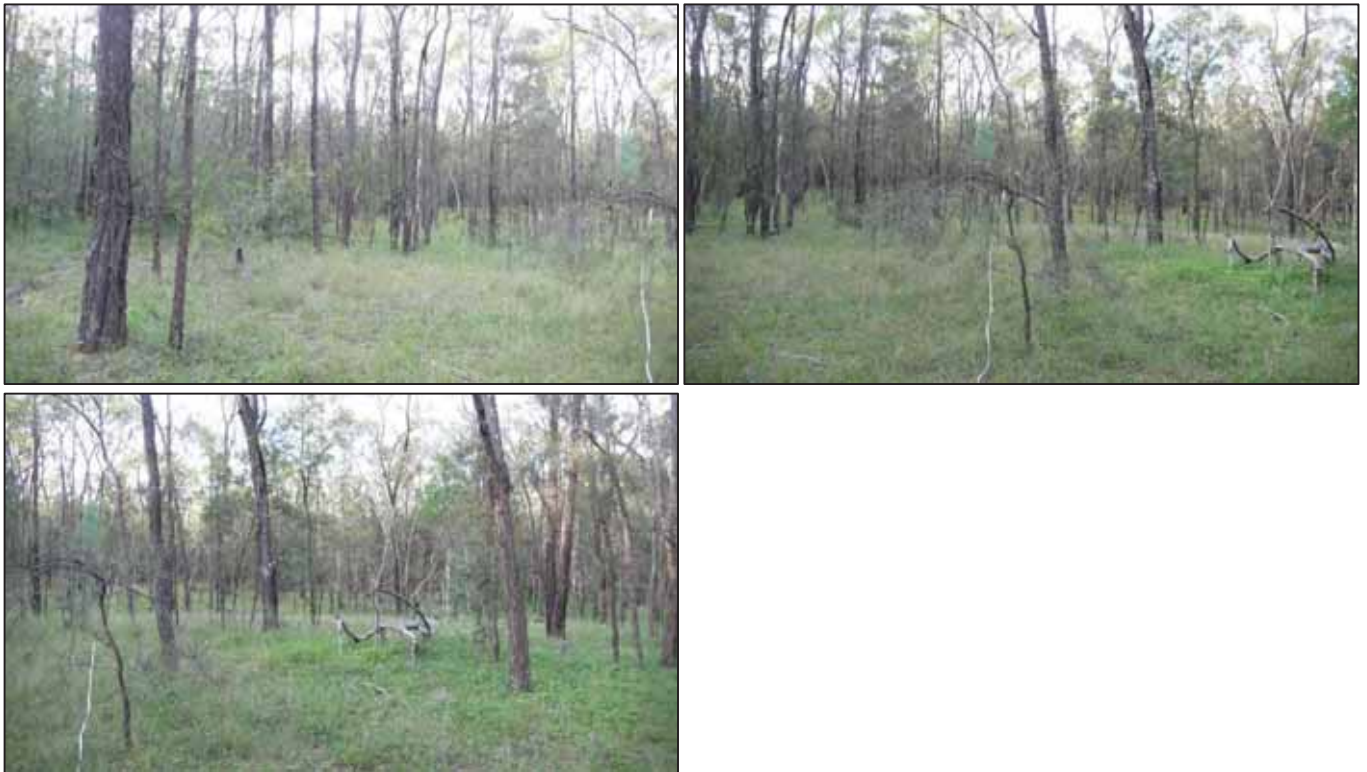
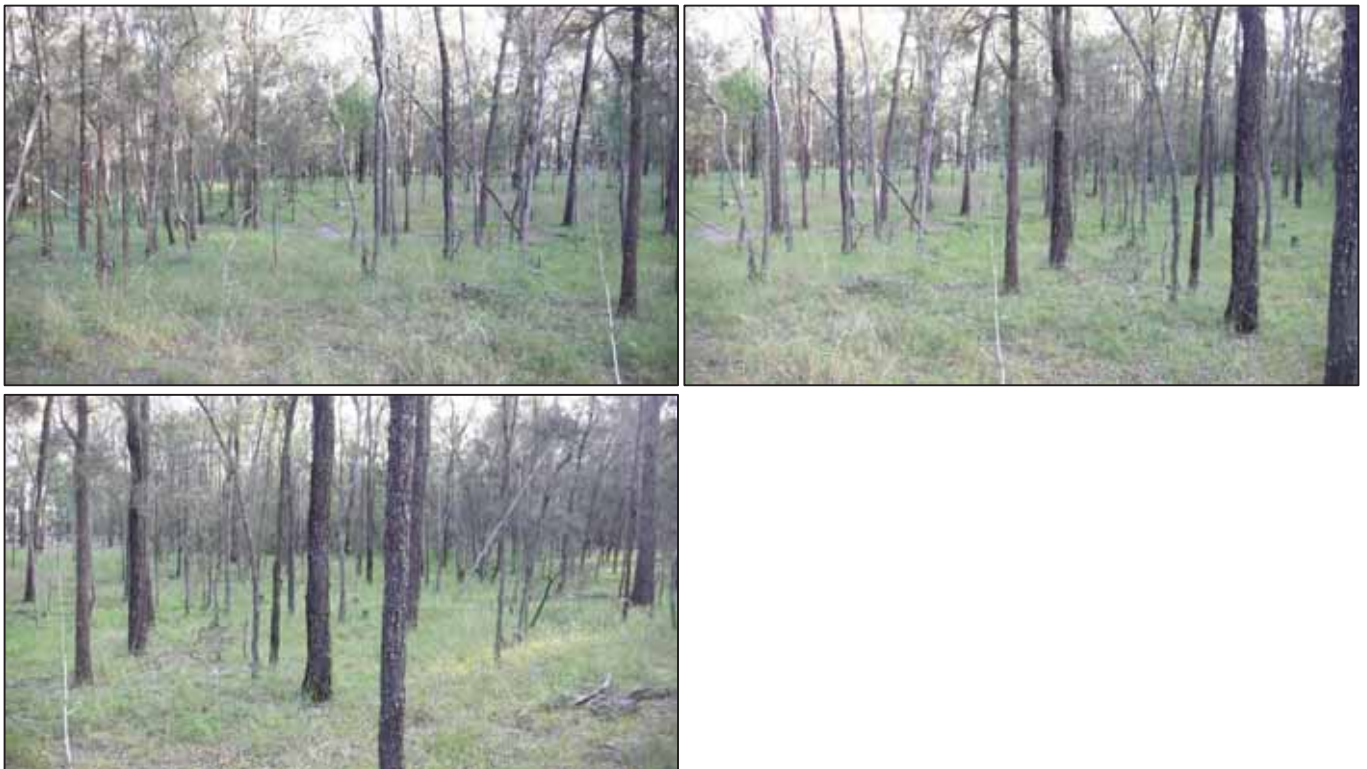
## Site photographs at Warkworth Grey Box 02 (left to right)

No damage from fire activity was observed at the site.

No access tracks, or evidence of trail bikes or foot traffic was observed at the site.

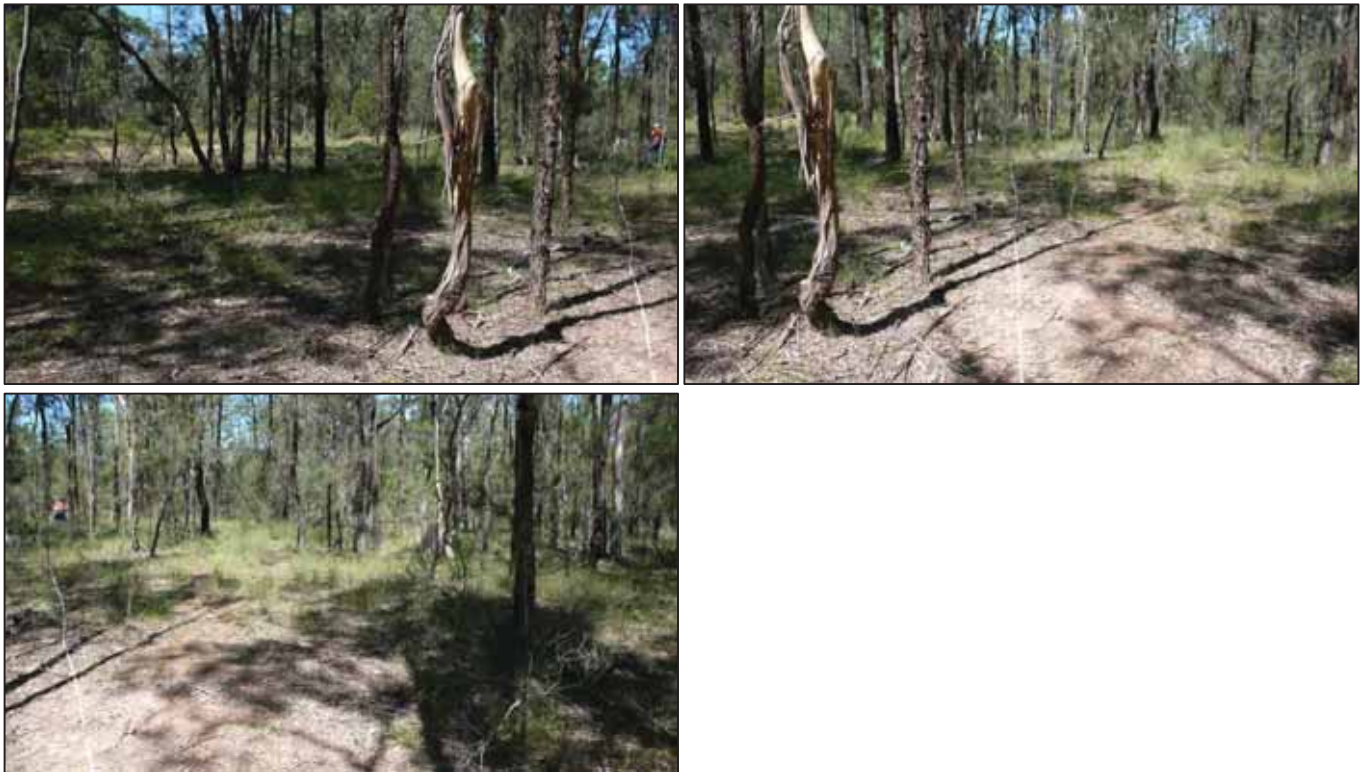
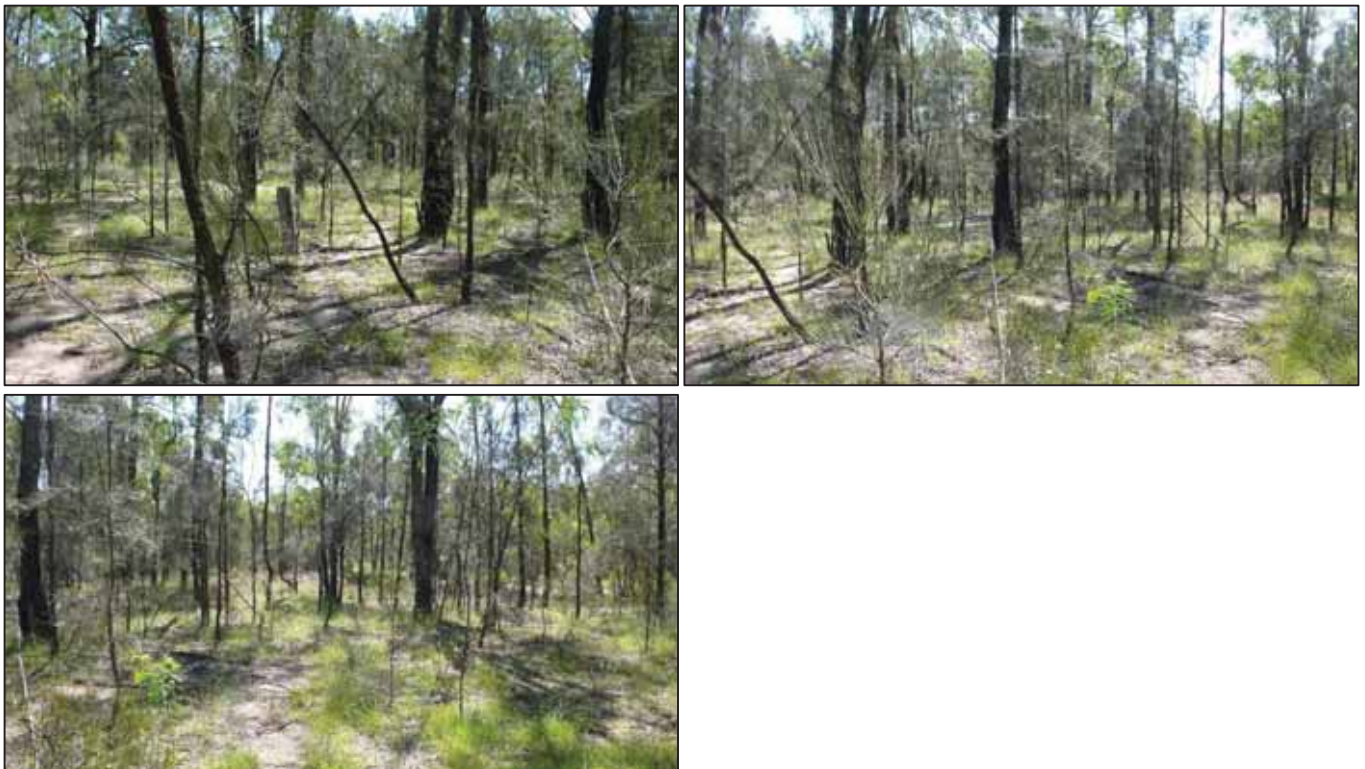
## Site photographs at Warkworth Grey Box 03 (left to right)

No damage from fire activity was observed at the site.

No access tracks, or evidence of trail bikes or foot traffic was observed at the site.

Stratum	Height(m)	% cover*	Dominant native species
Tree layer	15 - 25	10-20	<i>Eucalyptus tereticornis</i> and <i>Eucalyptus crebra</i> ,
Midstorey layer	5-10	10-20	<i>Allocasuarina luehmannii</i>
Shrub layer	2	10-20	<i>Acacia amblygona</i> <i>Breynia oblongifolia</i> and <i>Bursaria spinosa</i> ,
Ground layer	1	30-40	<i>Alternanthera</i> spp., <i>Austrodanthonia racemosa</i> , <i>Austrostipa scabra</i> , <i>Cheilanthes sieberi</i> , <i>Chrysocephalum apiculatum</i> , <i>Commelina cyanea</i> , <i>Cymbopogon refractus</i> , <i>Cynodon dactylon</i> , <i>Cyperus gracilis</i> , <i>Desmodium varians</i> , <i>Dianella caerulea</i> , <i>Eragrostis brownii</i> , <i>Eragrostis elongata</i> , <i>Eremophila debilis</i> , <i>Fimbristylis tristachya</i> , <i>Glycine tabacina</i> , <i>Goodenia hederacea</i> , <i>Hypochaeris radicata</i> , <i>Laxmannia gracilis</i> , <i>Lomandra multiflora</i> , <i>Melaleuca decora</i> , <i>Melinis repens</i> , <i>Microlaena stipoides</i> , <i>Oxalis perennans</i> , <i>Pennisetum clandestinum</i> , <i>Poa sieberiana</i> , <i>Themeda australis</i> and <i>Wahlenbergia stricta</i> .
