## Hunter Valley Operations

### 2015 Annual Environmental Review

March 2016

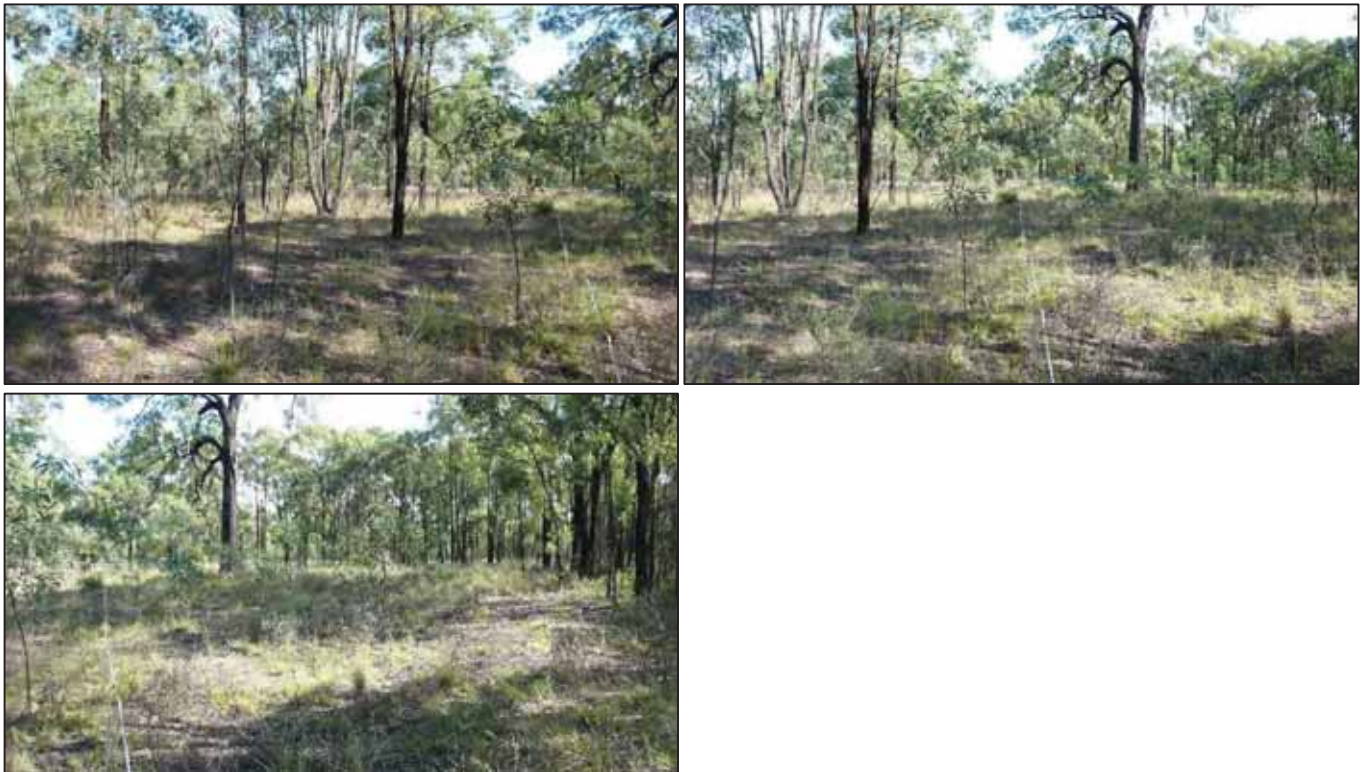
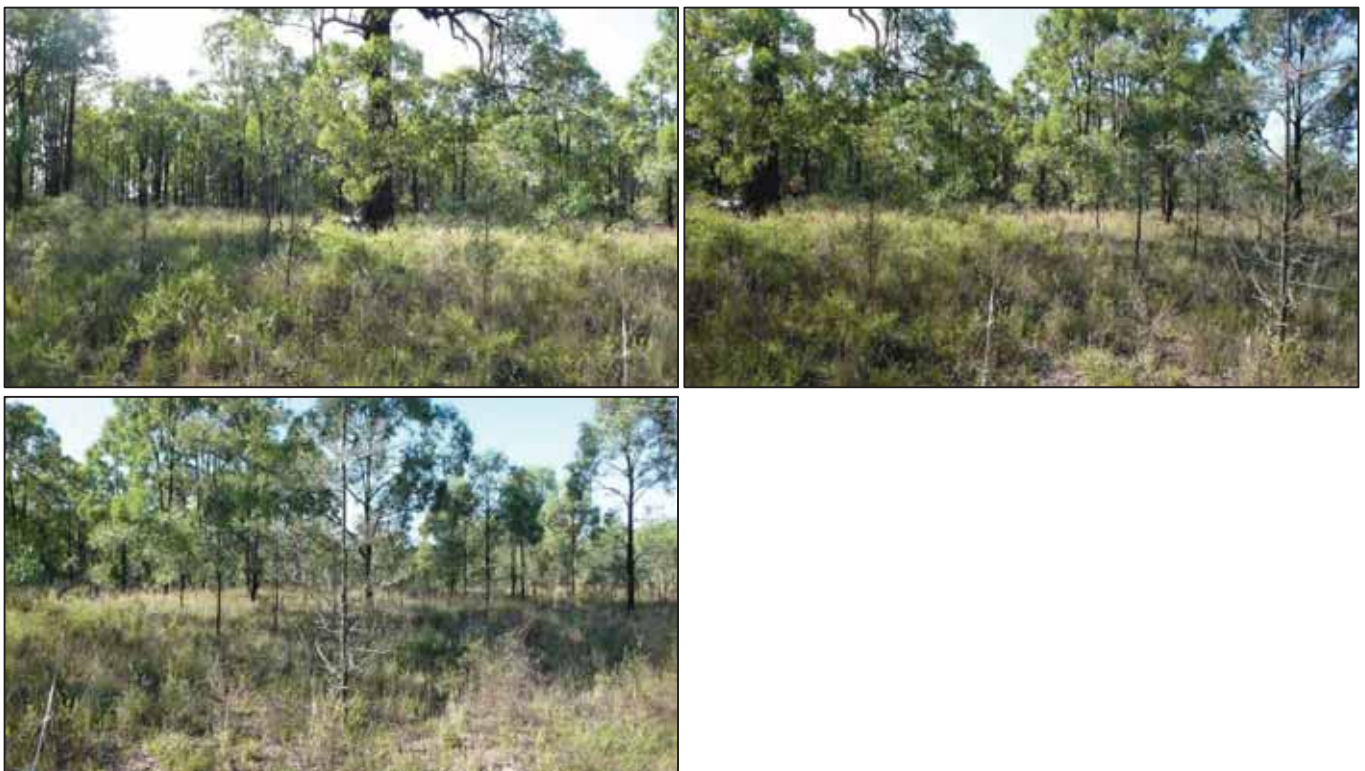
## Site photographs at Warkworth Grey Box 04 (left to right)

Disturbance present at the site consisted of few weed species. Weeds recorded include *Melinis repens*, *Eragrostis curvula*, *Opuntia* spp., *Bidens pilosa* and *Senecio madagascariensis*.

No damage from fire activity was observed at the site.

No access tracks, or evidence of trail bikes or foot traffic was observed at the site.

Stratum	Height(m)	% cover*	Dominant native species
Tree layer	15 - 25	10-20	<i>Eucalyptus crebra</i> ,
Midstorey layer	5-10	10-20	<i>Acacia amblygona</i> , <i>Acacia falcate</i> and <i>Allocasuarina luehmannii</i> ,
Shrub layer	2	10-20	<i>Daviesia ulicifolia</i> ,
Ground layer	1	30-40	<i>Aristida ramosa</i> , <i>Austrostipa scabra</i> , <i>Bothriochloa macra</i> , <i>Calotis lappulacea</i> , <i>Cheilanthes sieberi</i> , <i>Chloris truncata</i> , <i>Chloris ventricosa</i> , <i>Commelina cyanea</i> , <i>Cymbopogon refractus</i> , <i>Cynodon dactylon</i> , <i>Cyperus gracilis</i> , <i>Dichondra repens</i> , <i>Eragrostis brownii</i> , <i>Eremophila debilis</i> , <i>Fimbristylis tristachya</i> , <i>Galenia pubescens</i> , <i>Glycine tabacina</i> , <i>Goodenia rotundifolia</i> , <i>Hardenbergia violacea</i> , <i>Oxalis perennans</i> , <i>Panicum effusum</i> , <i>Paspalidium</i> spp., <i>Sida rhombifolia</i> , <i>Solanum prinophyllum</i> , <i>Themeda australis</i> and <i>Wahlenbergia gracilis</i> .

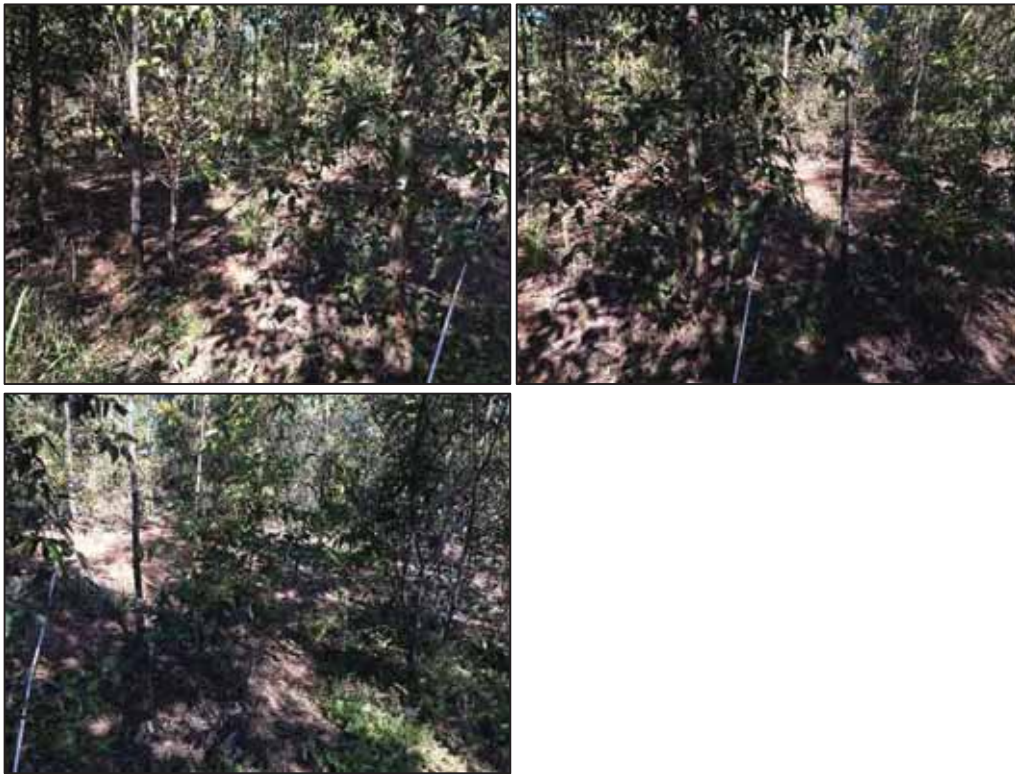
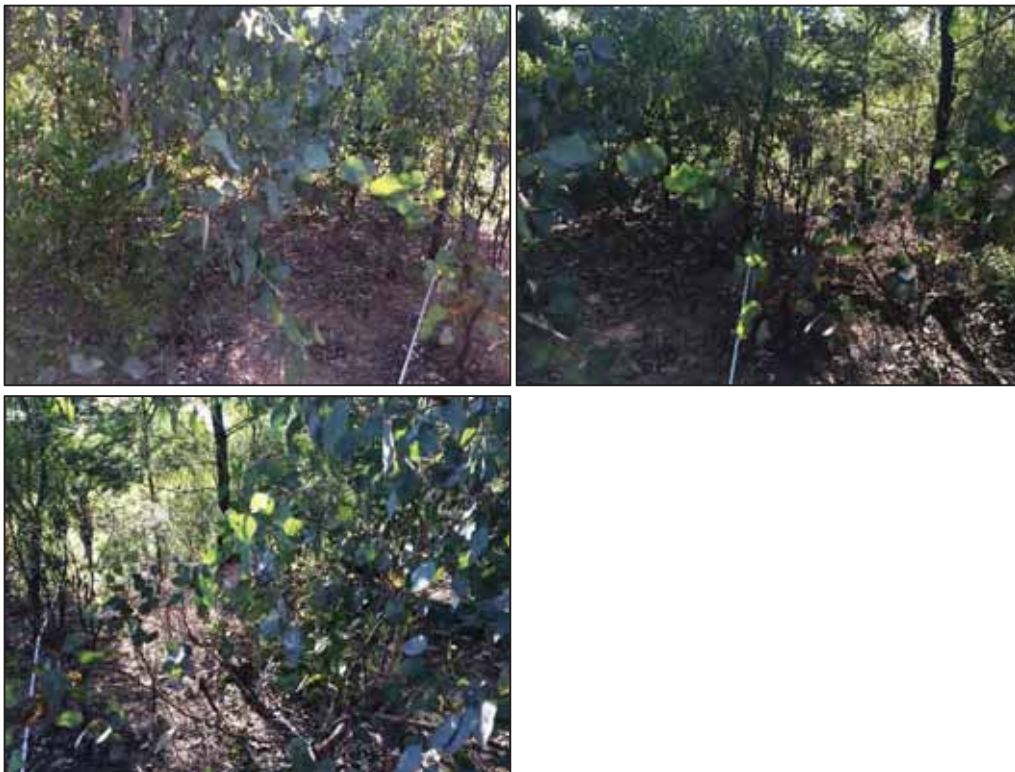
## Site photographs at HVOCAR2009-01 (left to right)

Disturbance present at the rehabilitation site consisted mainly of weeds, and grazing by macropods. No evidence of fire was observed in the rehabilitation area. No areas containing rubbish were observed.

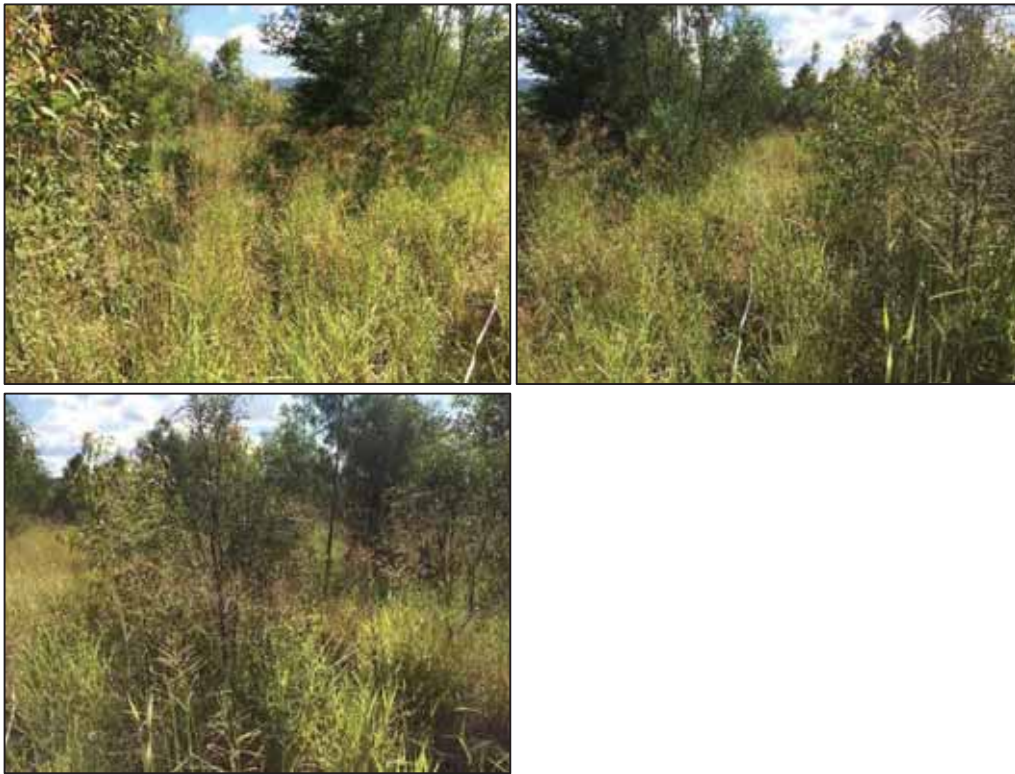
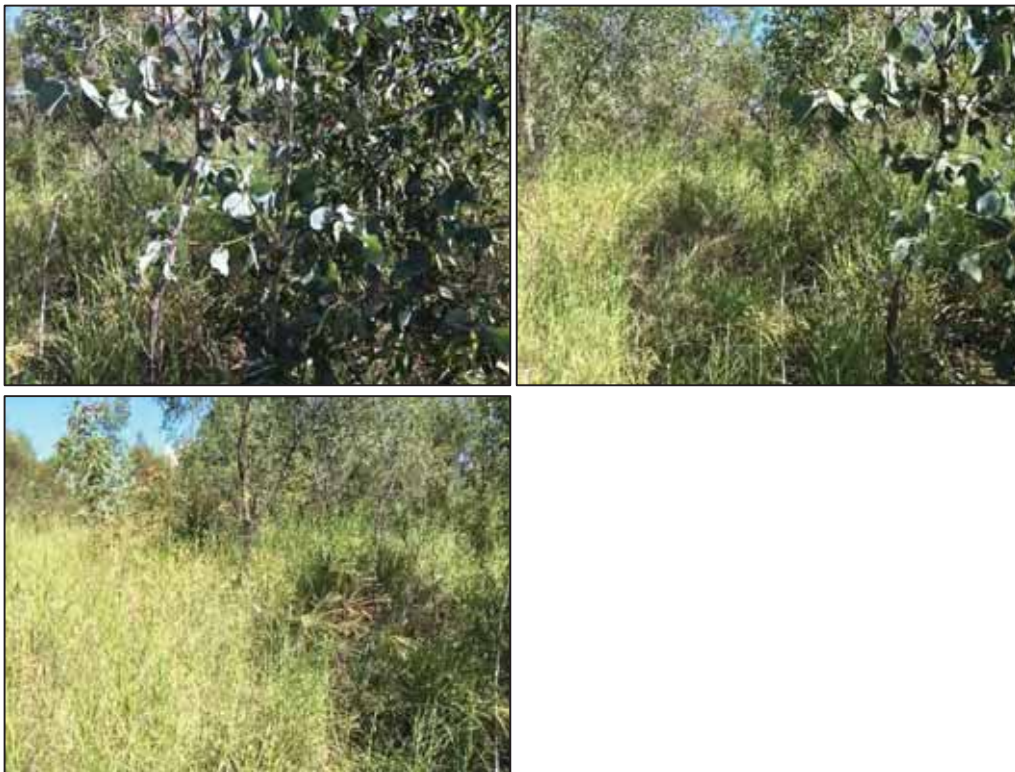
## Site photographs at HVOCAR2009-02 (left to right)

Disturbance present at the rehabilitation site consists mainly of weeds, and grazing by macropods. No evidence of fire was observed in the rehabilitation area. No areas containing rubbish were observed.

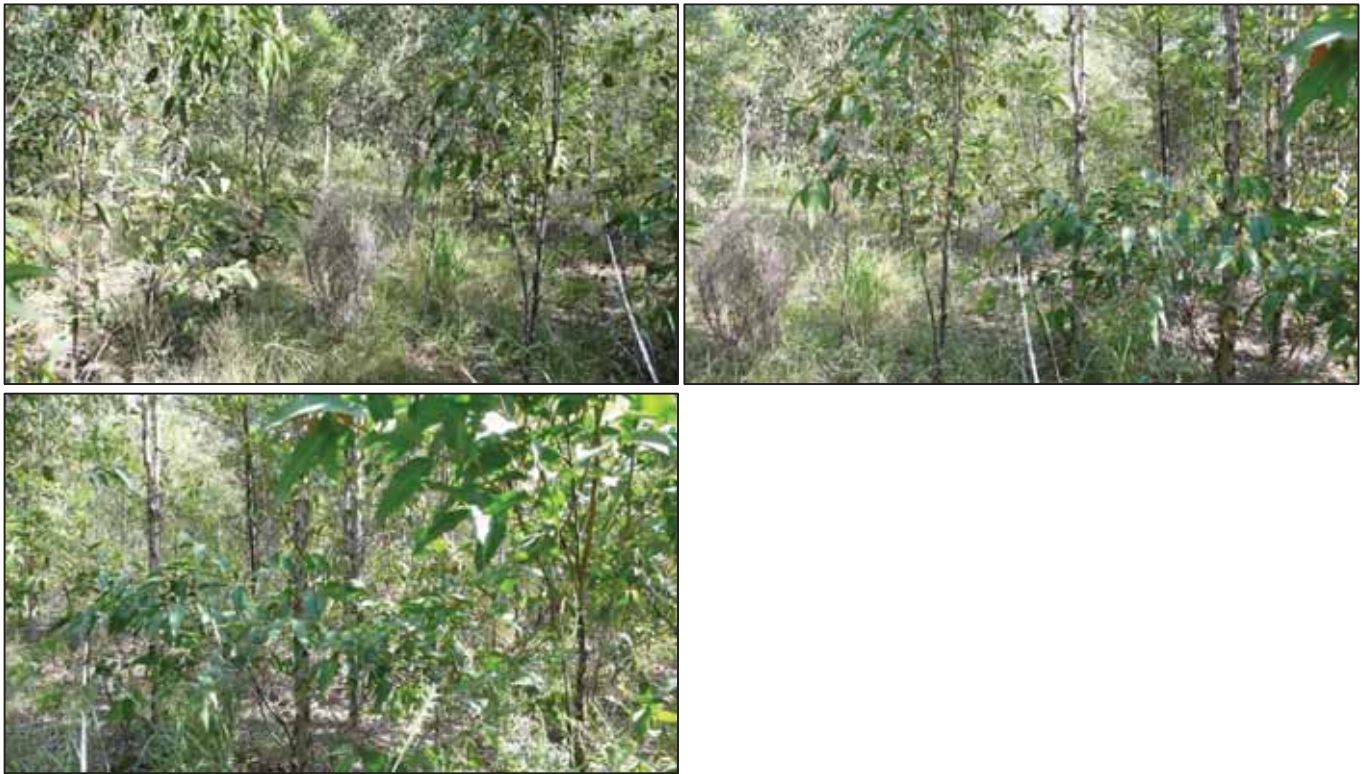
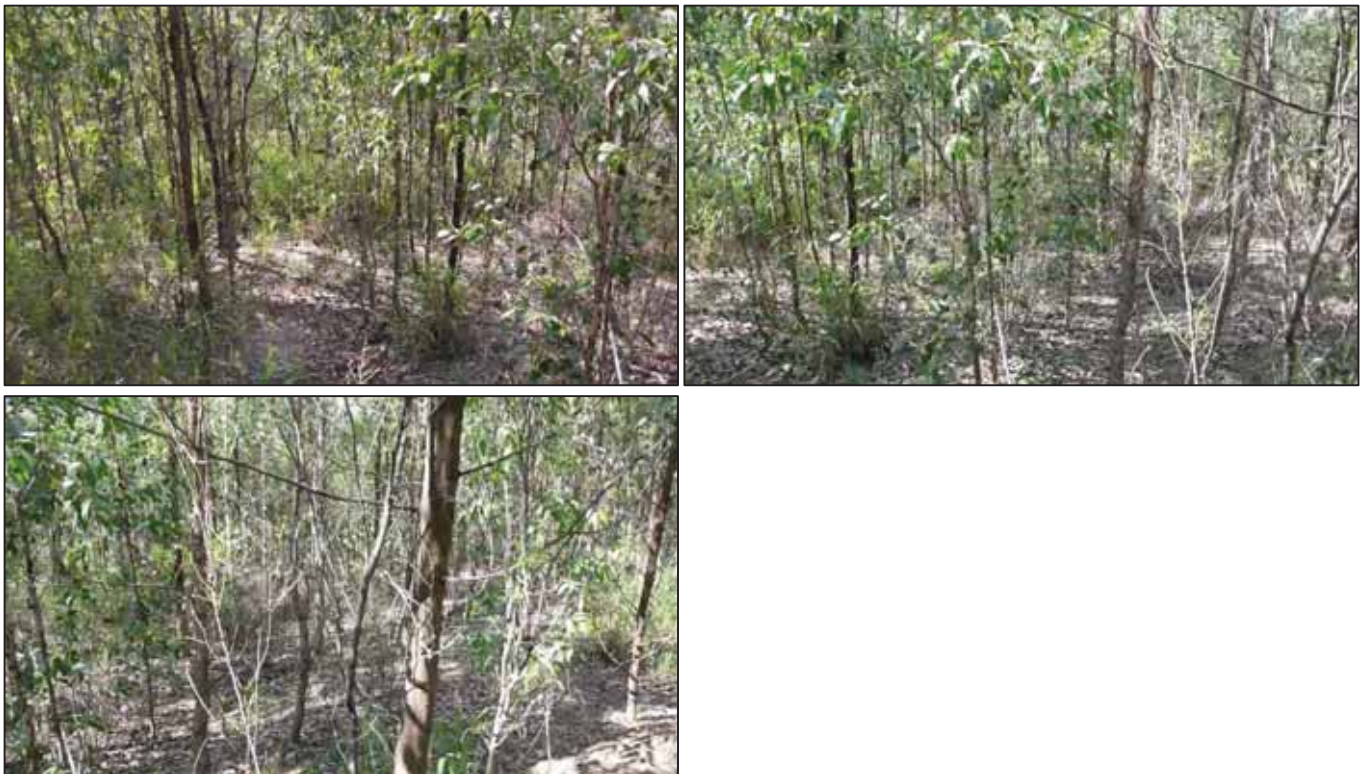
## Site photographs at HVOWES2008-01 (left to right)

Disturbance present at the rehabilitation site consisted mainly of weeds, and grazing by macropods. No evidence of fire was observed in the rehabilitation area. No areas containing rubbish were observed.

Stratum	Height (m)	% cover*	Dominant native species
Tree layer	5	20	<i>Eucalyptus punctate</i> and <i>Corymbia maculata</i>
Midstorey layer	2 – 4	30	<i>Acacia parvipula</i> , <i>Acacia mearnsii</i> , <i>Acacia dealbata</i> and <i>Acacia amblygona</i> ,
Shrub layer	2	25	<i>Acacia paradoxa</i> , <i>Acacia mearnsii</i> , <i>Acacia dealbata</i> and <i>Acacia amblygona</i>
Ground layer	1	40	<i>Austrostipa ramossissima</i> , <i>Bothriochloa macra</i> , <i>Plantago debilis</i> , <i>Dichondra repens</i> , <i>Sporobolous creber</i> , <i>Chloris ventricosa</i> , <i>Enchylaena tomentose</i> and <i>Glycine tabacina</i> .

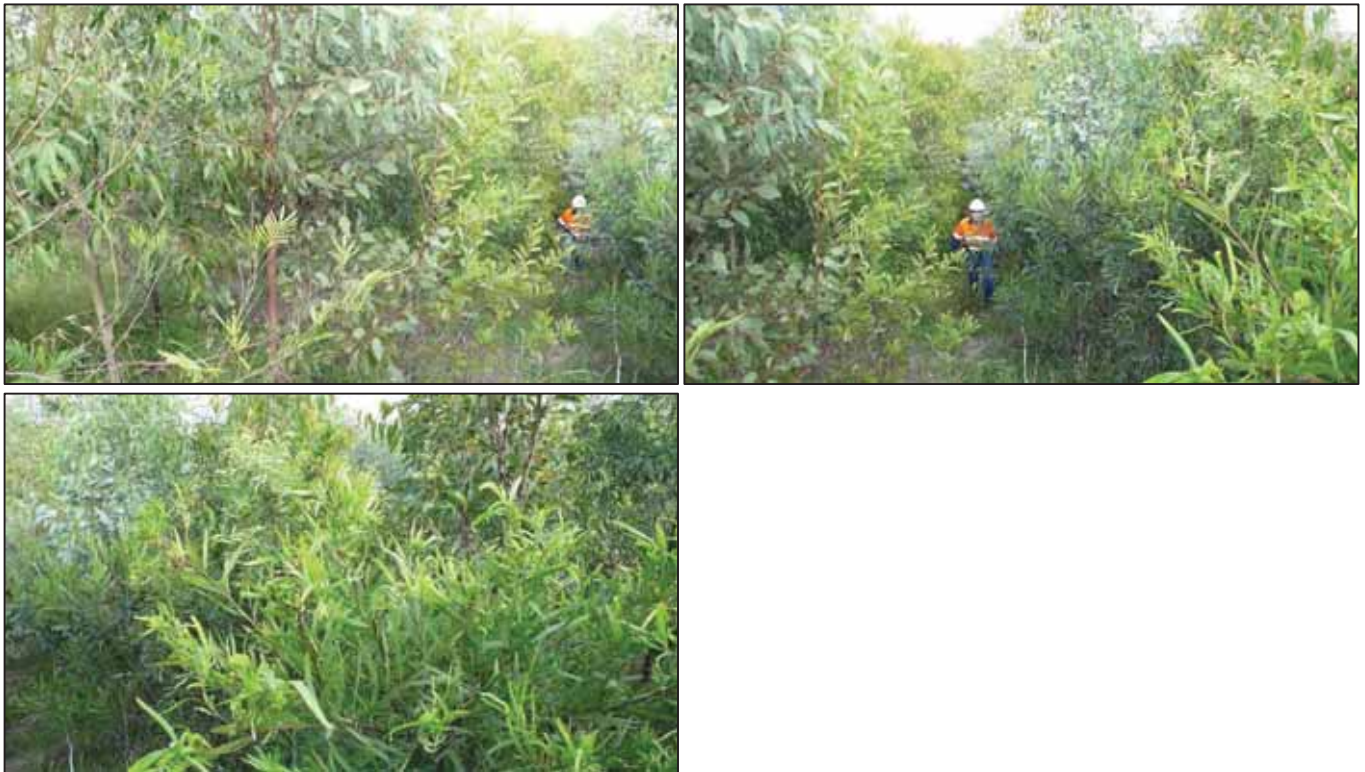
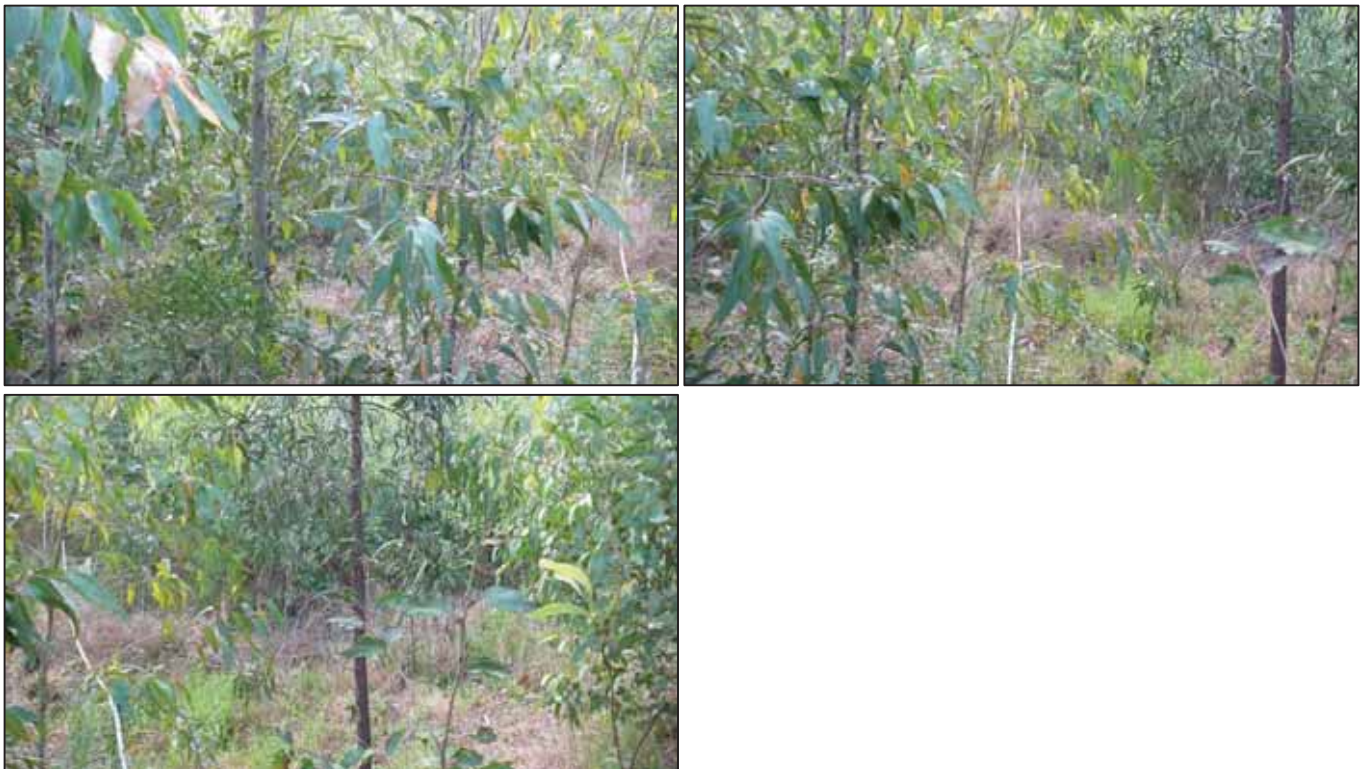
## Site photographs at HVOWES2011-01 (left to right)

Disturbance present at the site consisted mainly of weeds, and grazing by macropods. No evidence of fire was observed in the rehabilitation area. No areas containing rubbish were observed.

Stratum	Height	% cover*	Dominant native species
Tree layer	-	-	-
Midstorey layer	5-6	50	<i>Eucalyptus crebra</i> , <i>Eucalyptus punctata</i> , <i>Corymbia maculata</i> , <i>Acacia longifolia</i> , <i>Allocasuarina littoralis</i> , <i>Acacia implexa</i> , <i>Acacia binervata</i> , and <i>Acacia falcata</i> .
Shrub layer	2	5	<i>Indigofera australis</i> and <i>Hakea sericea</i> .
Ground layer	1	60	<i>Austrostipa ramossissima</i> , <i>Bothriochloa macra</i> , <i>Dichondra repens</i> , <i>Sporobolous creber</i> , <i>Chloris truncata</i> , <i>Hardenbergia violacea</i> , <i>Microlaeana stipoides</i> , <i>Enchylaena tomentosa</i> , <i>Glycine tabacina</i> and <i>Themeda australis</i> .

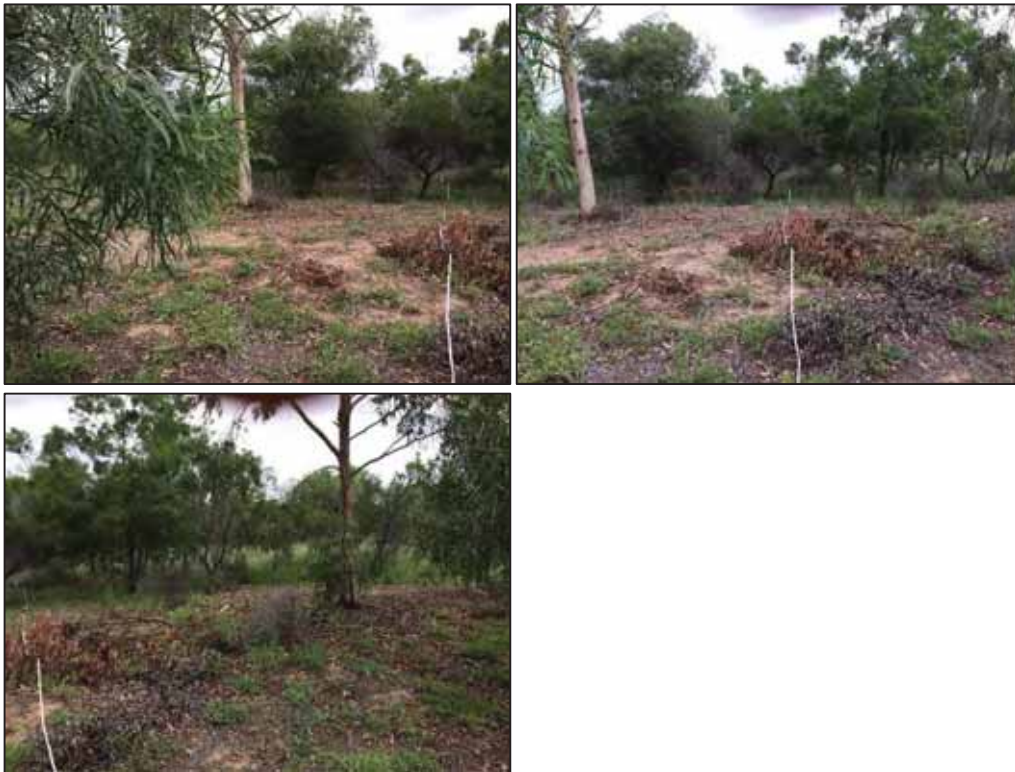
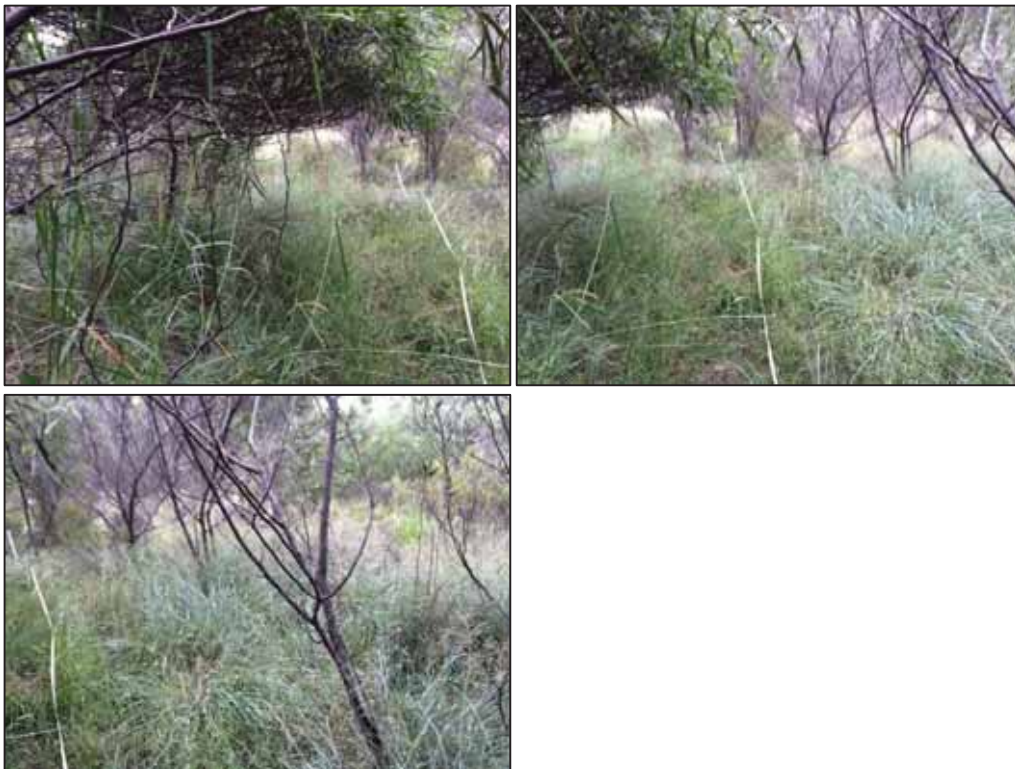
## Site photographs at MTWNPN2005-01 (left to right)

Disturbance present at the rehabilitation site consisted mainly of weeds, and grazing by macropods. No evidence of fire was observed in the rehabilitation area. No areas containing rubbish were observed.

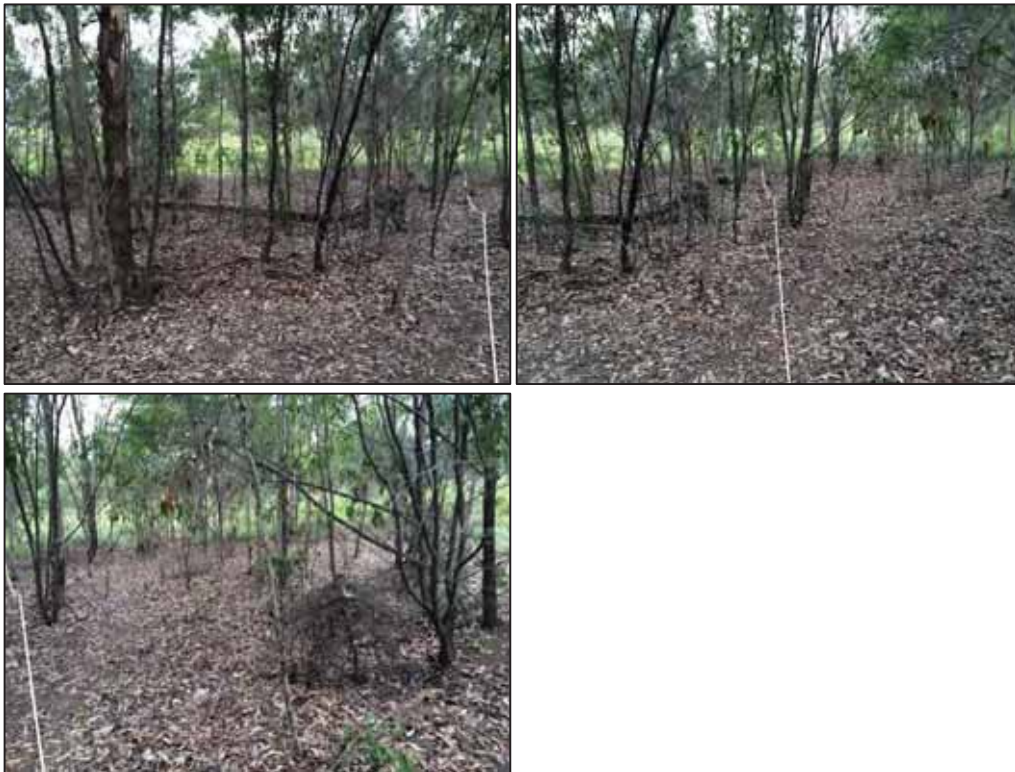
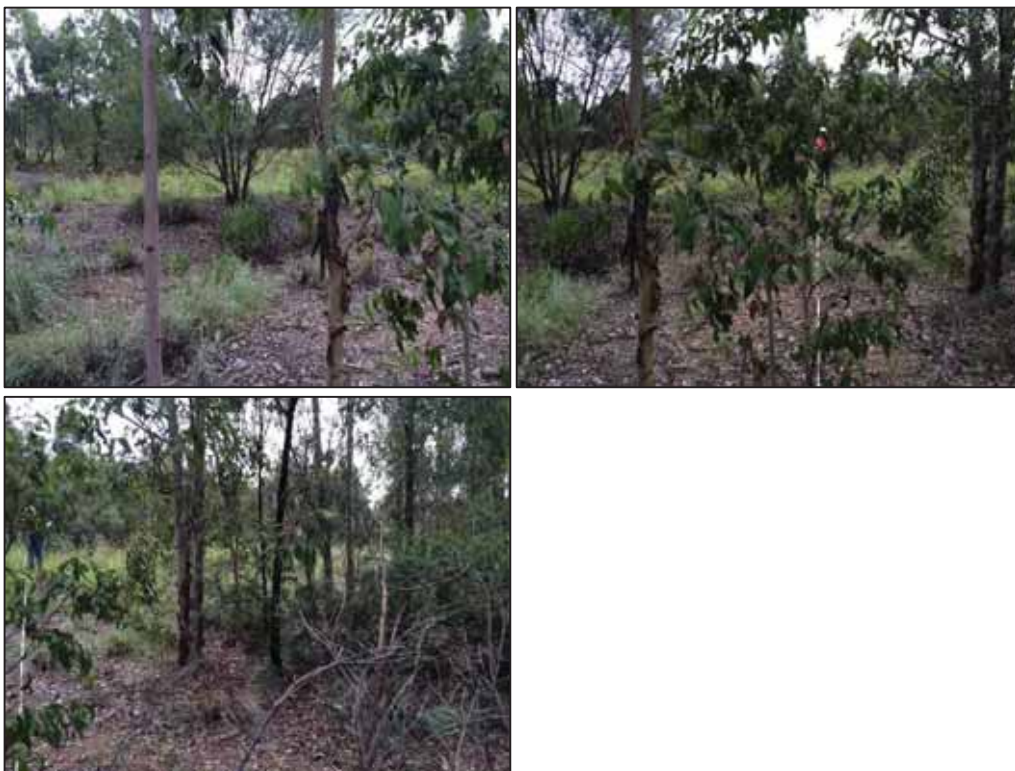
## Site photographs at MTWNPN2005-02 (left to right)

Disturbance present at the rehabilitation site consisted mainly of weeds, and grazing by macropods. No evidence of fire was observed in the rehabilitation area. No areas containing rubbish were observed.

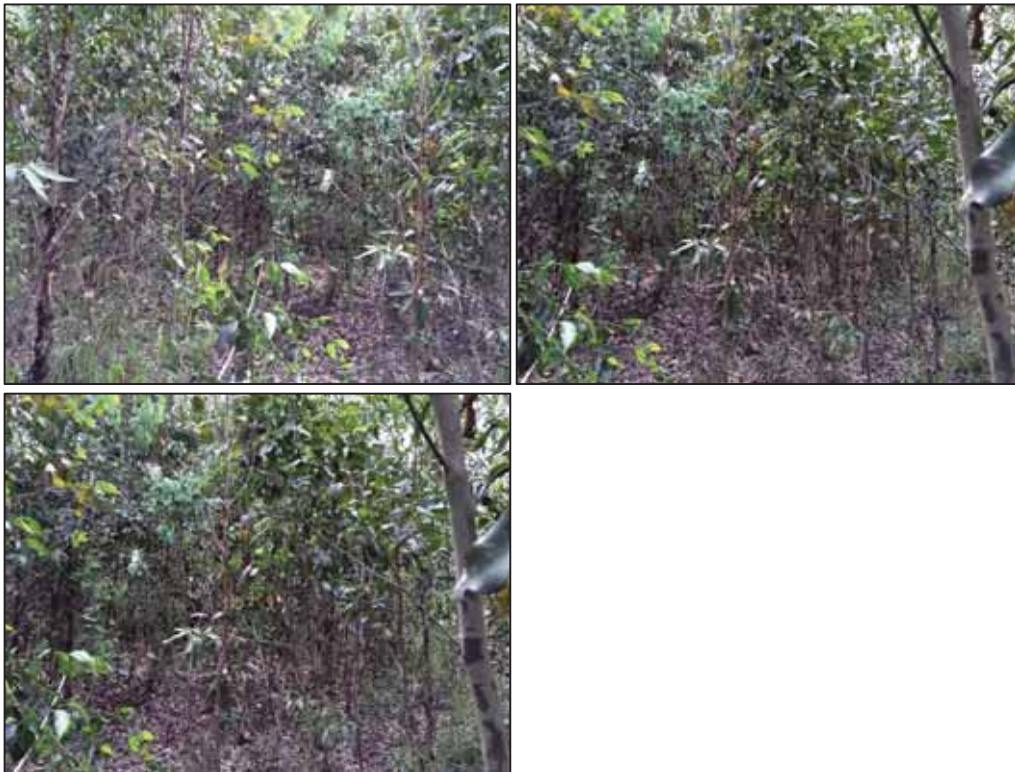
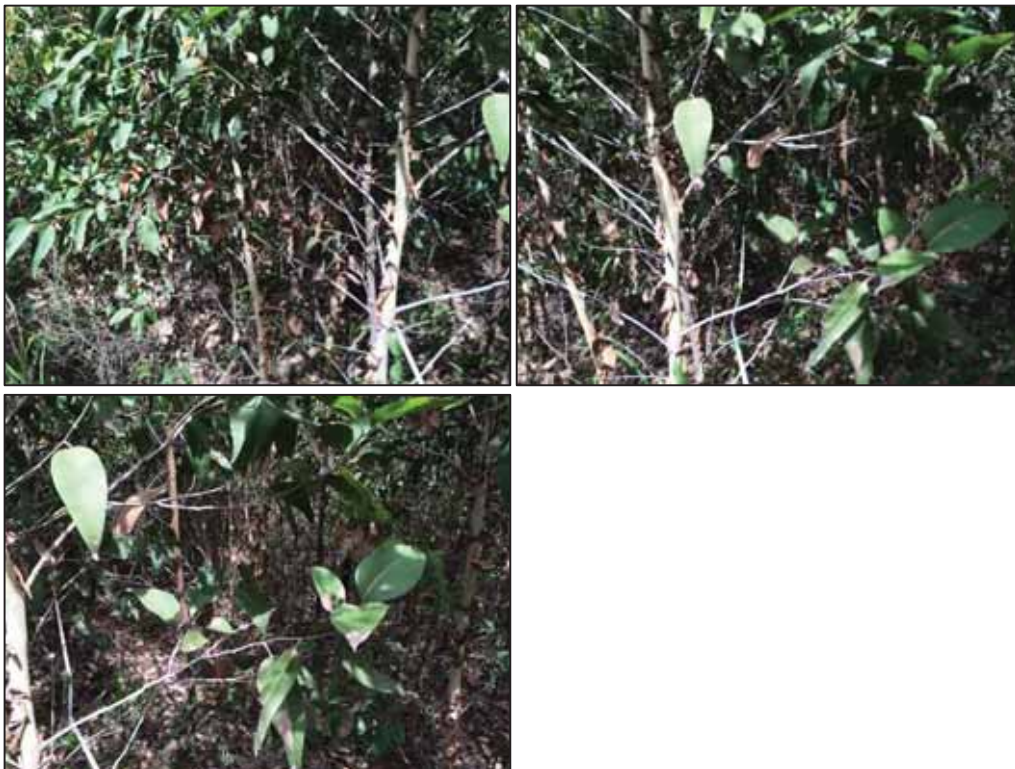
## Site photographs at MTWNPN2009-01 (left to right)

Disturbance present at the site consisted mainly of weeds, and grazing by macropods. No evidence of fire was observed in the rehabilitation area. No areas containing rubbish were observed.

Pig scats were found at the site during the monitoring.

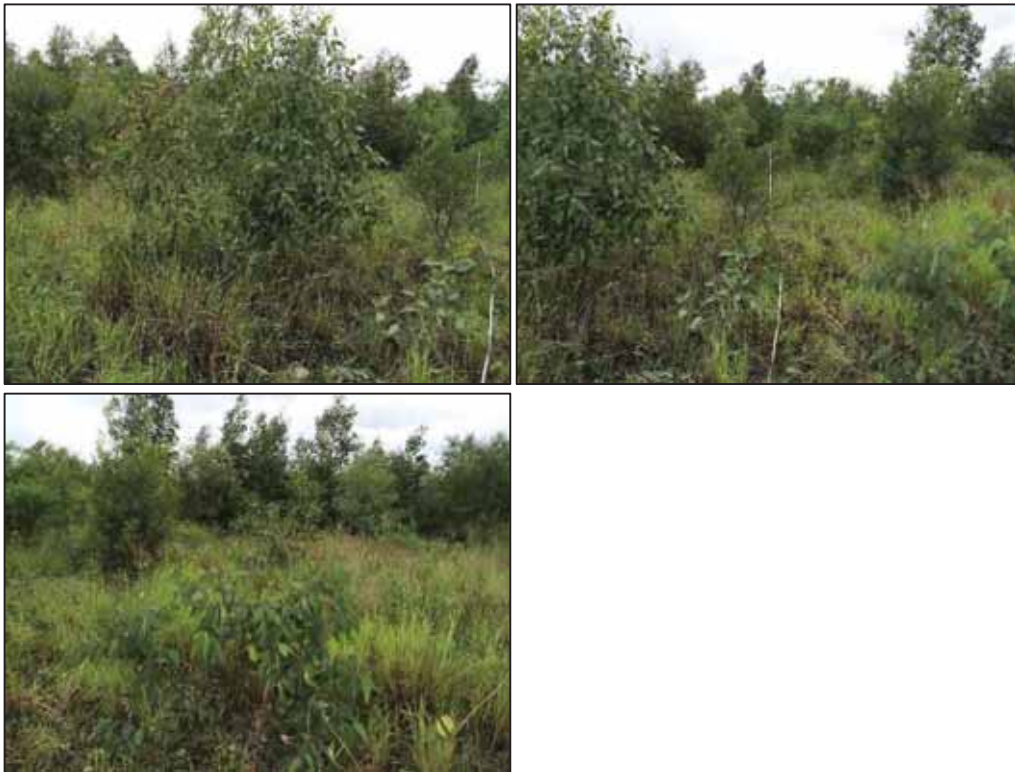
Site photographs at MTWCDC2011-01 (left to right)

Disturbance present at the site consisted mainly of weeds, and grazing by macropods. No evidence of fire was observed in the rehabilitation area. No areas containing rubbish were observed.

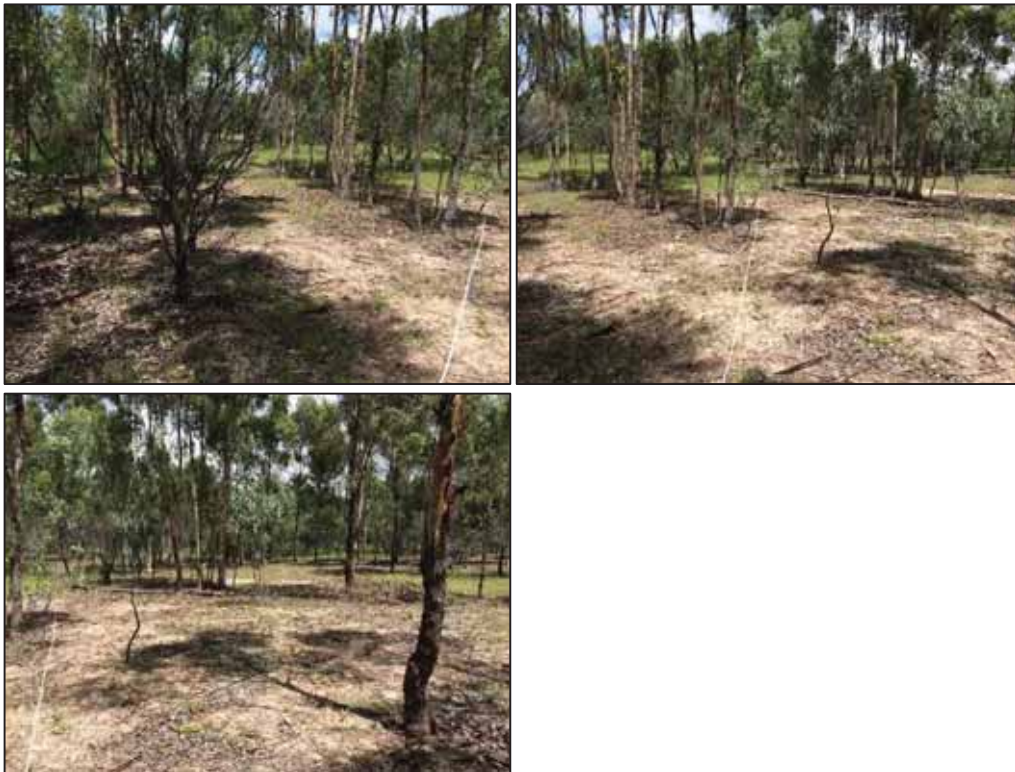
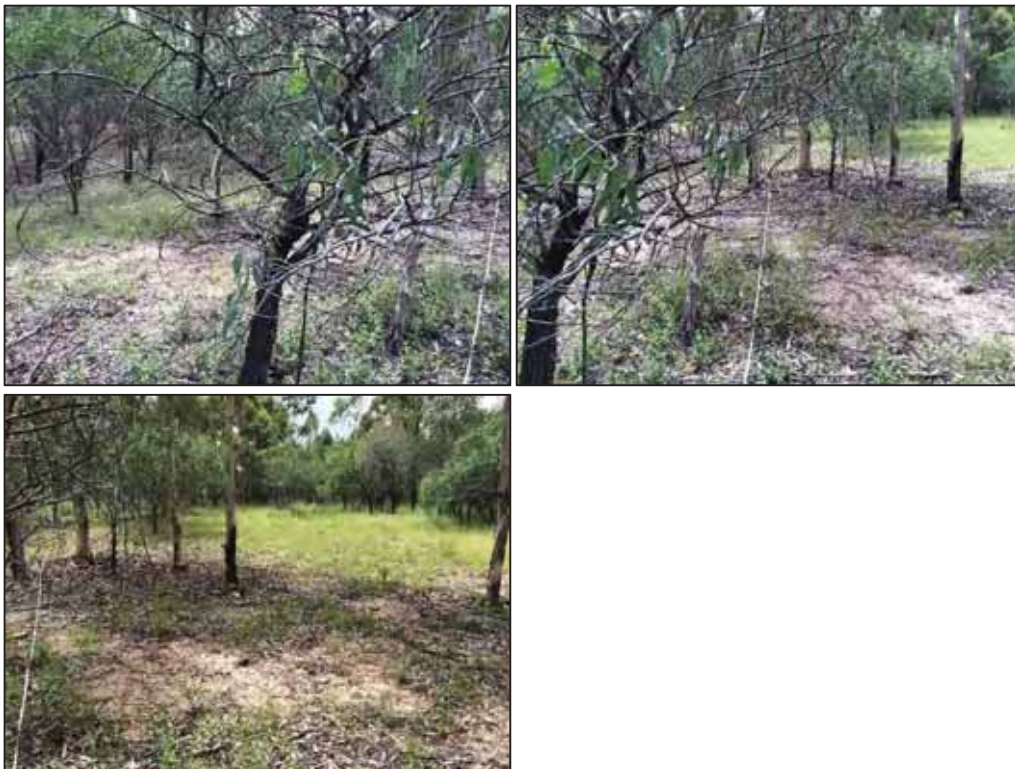
## Site photographs at MTWMT02000-01 (left to right)

Disturbance present at the site consisted mainly of weeds, and grazing by macropods. No evidence of fire was observed in the rehabilitation area. No areas containing rubbish were observed.

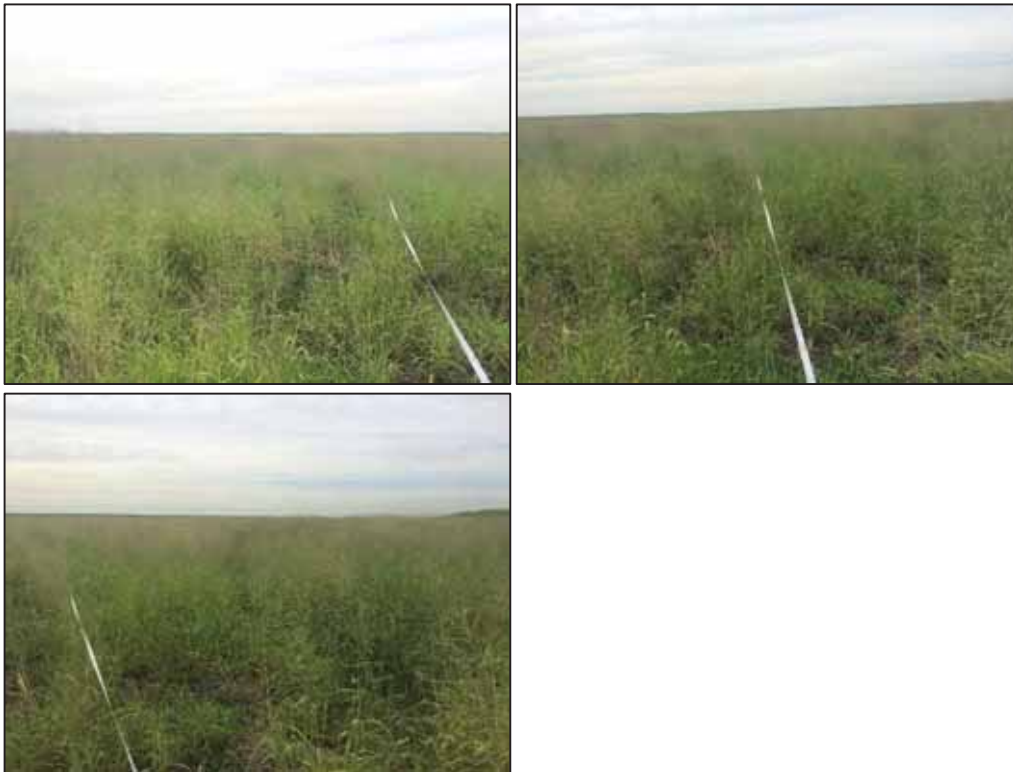
## Site photographs at HVORIV2013-01 (left to right)

Disturbance present at rehabilitation site HVORIV2013-01 consisted mainly of weeds, and grazing by macropods. No evidence of fire was observed in the rehabilitation area. No areas containing rubbish were observed.

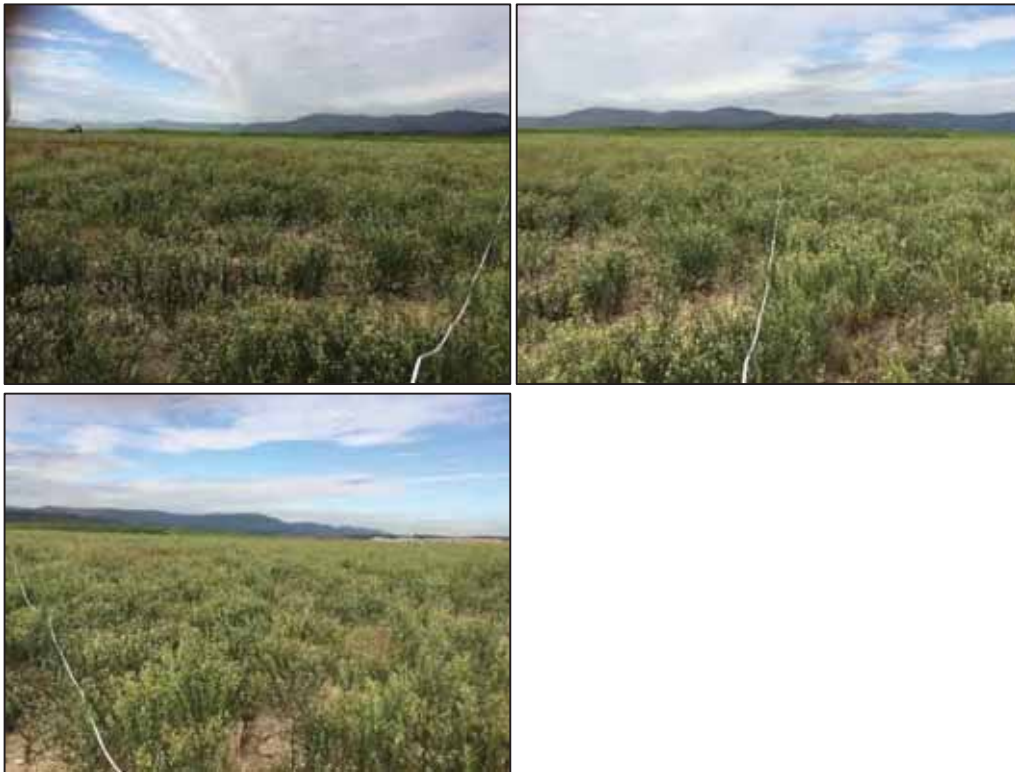
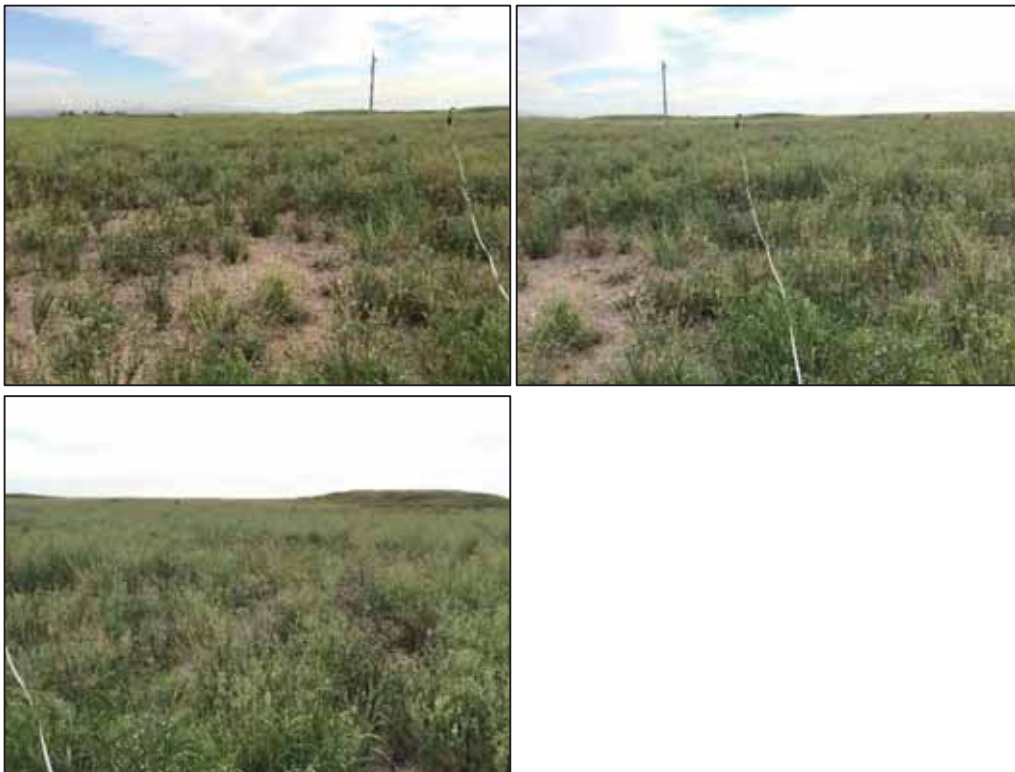
## Site photographs at HVORIV2014-01 (left to right)

HVORIV2014-01 rehabilitation area occurs on a combination of spoil and compost at HVO West. The rehabilitation site is dominated by *Conyza bonariensis*. Other species include *Chloris gayana*, *Bidens pilosa*, *Bothriochloa macra*, *Galenia pubescens*, *Plantago lanceolata*, *Senecio mada gascariensis*, *Gomphocarpus fruticosus*, *Panicum maximum*, *Plantago lanceolata*, *Nicotiana glauca* and *Solanum nigrum*. It should be noted that a number of regenerating eucalypts (thin leaves – likely *E. crebra*), and small acacias and *Enchylaena tomentosa* were also recorded regenerating in the plot.

Disturbance present at rehabilitation site HVORIV2014-01 consisted mainly of weeds, and grazing by macropods. No evidence of fire was observed in the rehabilitation area. No areas containing rubbish were observed.

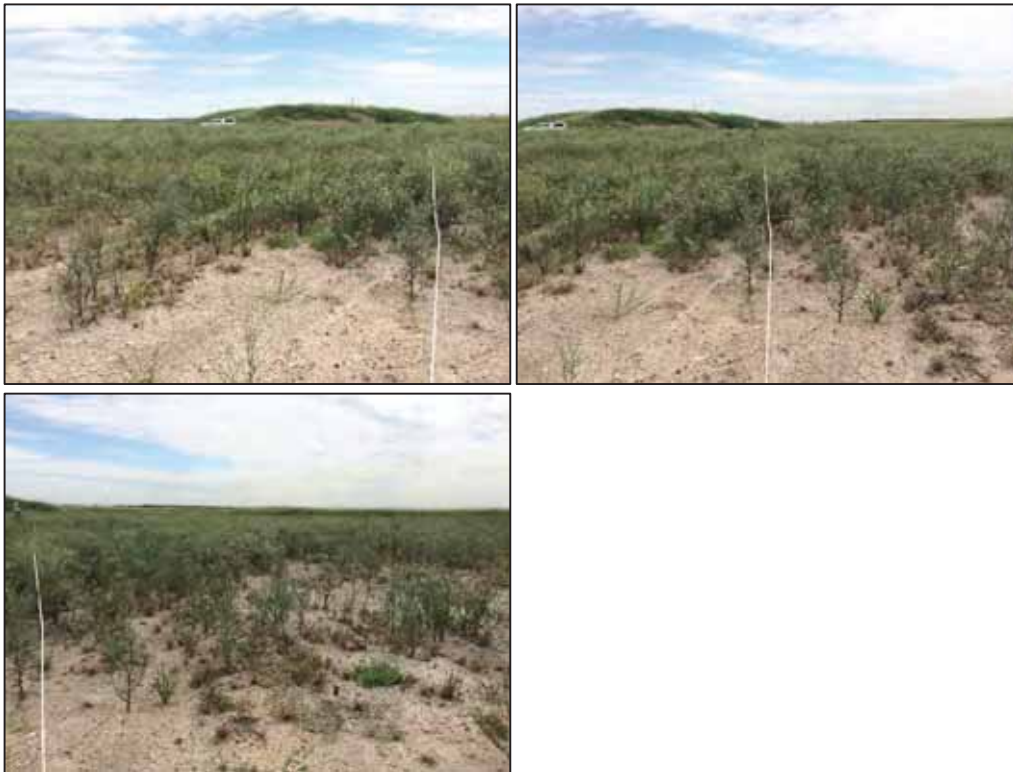
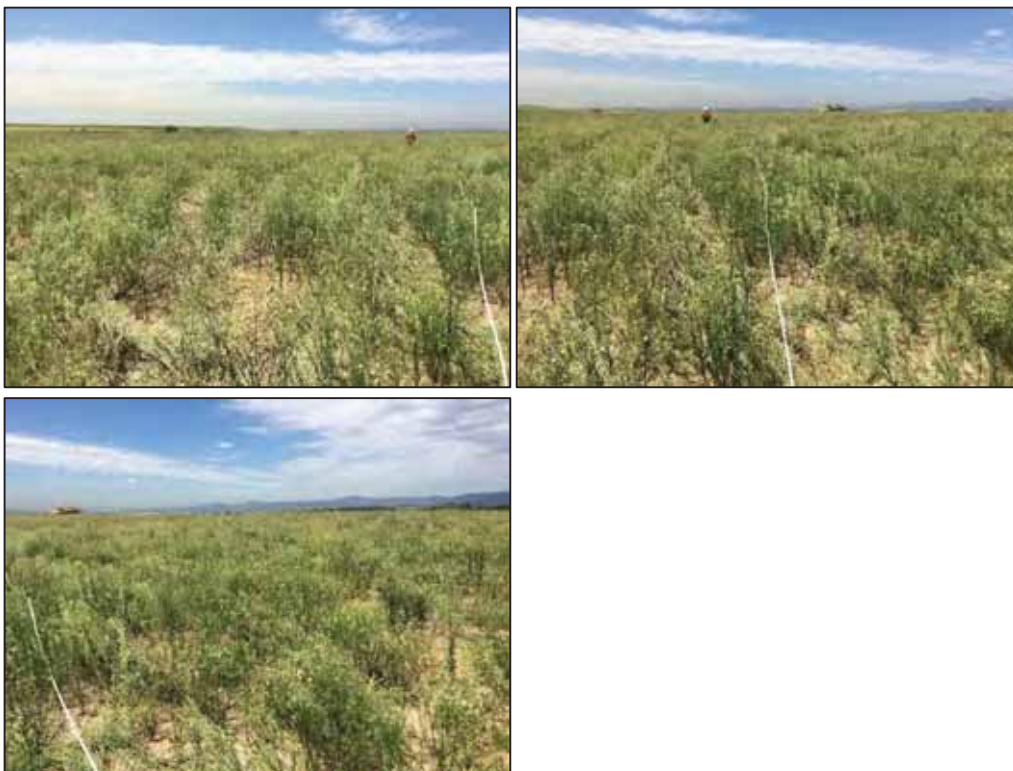
## Site photographs at HVORIV2014-02 (left to right)

HVORIV2014-02 rehabilitation area occurs on a combination of subsoil and compost at HVO West. The rehabilitation site is dominated by *Conyza bonariensis*. Other species include *Chloris gayana*, *Chloris truncata*, *Bidens pilosa*, *Bothriochloa macra*, *Galenia pubescens*, *Hypochaeris radicata*, *Plantago lanceolata*, *Senecio madagascariensis*, *Gomphocarpus fruticosus*, *Panicum maximum*, *Plantago lanceolata*, *Sida rhombifolia*, *Solanum nigrum* and *Polymeiria aviculare*. It should be noted that a number of regenerating eucalypts (thin leaves – likely *E. crebra*), small acacias (*Acacia decora*, *Acacia implexa*), *Salsola tragus* and *Enchylaena tomentosa* were also recorded regenerating in the plot.

Disturbance present at rehabilitation site HVORIV2014-02 consisted mainly of weeds, and grazing by macropods. No evidence of fire was observed in the rehabilitation area. No areas containing rubbish were observed.
