## Hunter Valley Operations

### 2015 Annual Environmental Review

March 2016

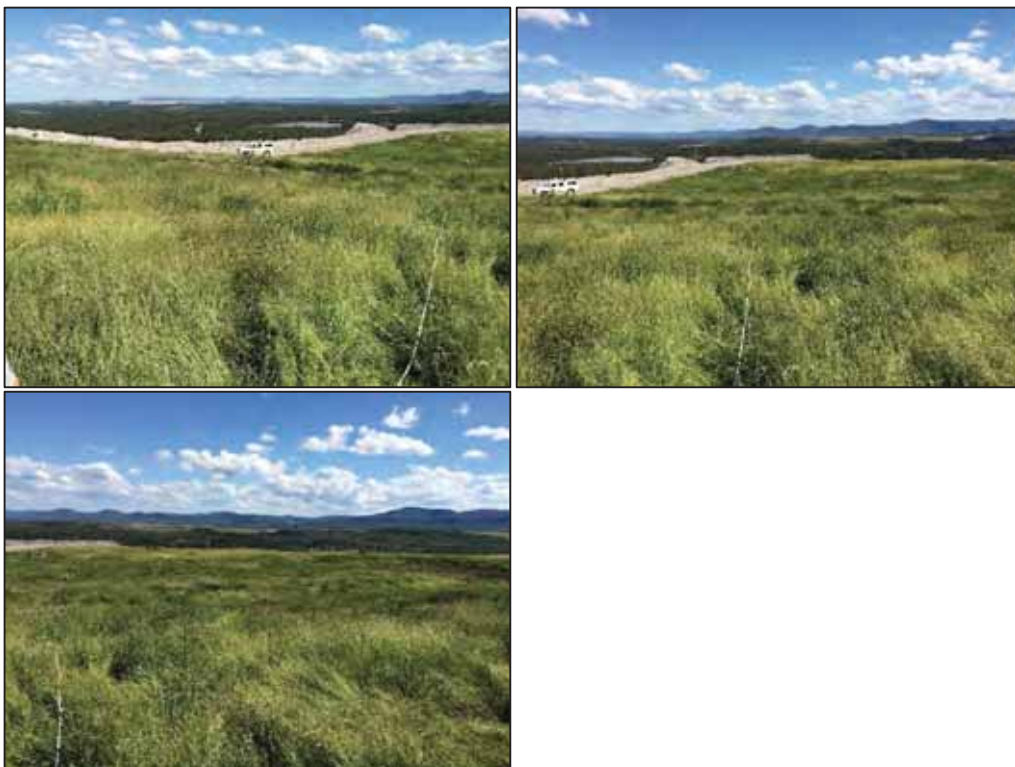
### End position

Disturbance present at rehabilitation site HVORIV2014-06 consisted mainly of weeds, and grazing by macropods. No evidence of fire was observed in the rehabilitation area. No areas containing rubbish were observed.

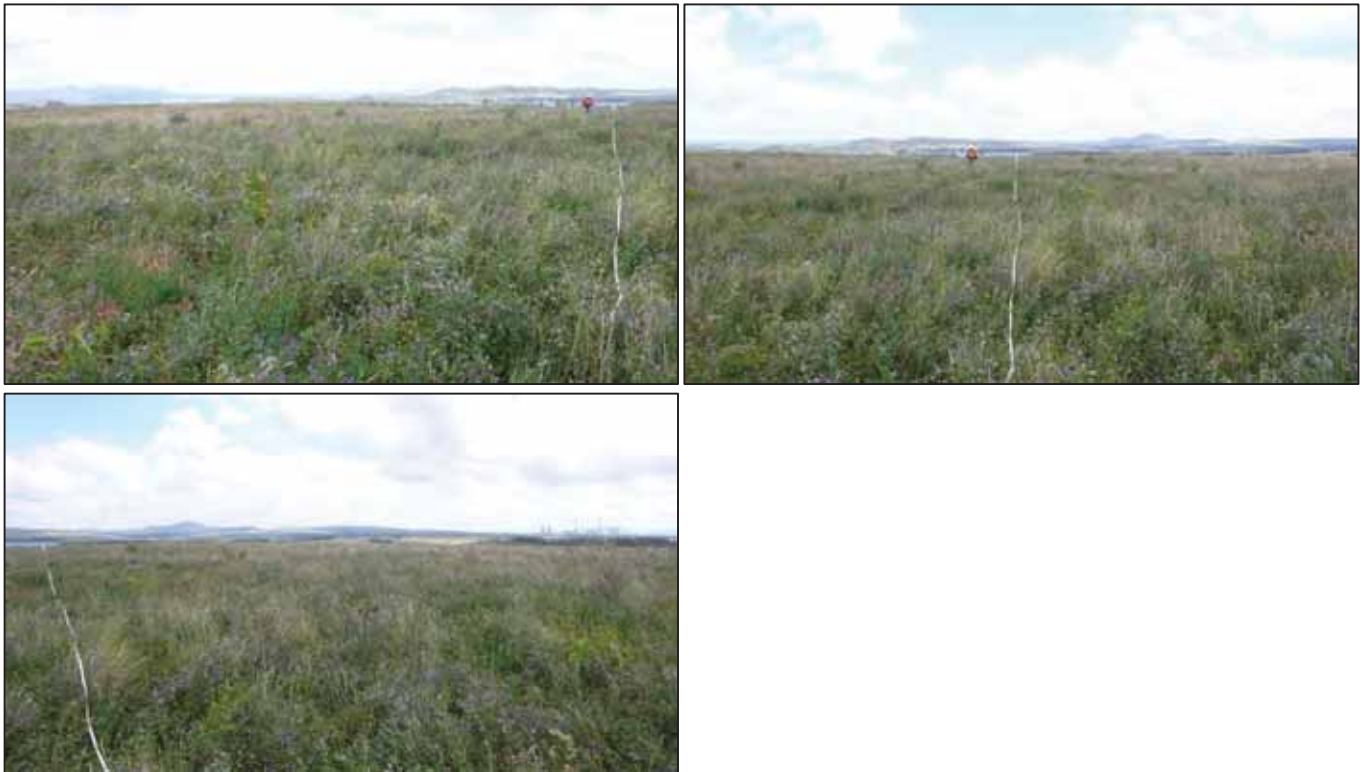
### Start position

HVOWES2013-01 rehabilitation area occurs on a combination of spoil and compost at HVO West. The rehabilitation site includes the following grasses: *Bothriochloa macra*, *Austrodanthonia* spp. (lack of seed head), *Eragrostis curvula*, *Chloris gayana* and *Chloris truncata*.

A number of eucalypts were observed within the rehabilitation area. It is likely that the eucalypts regenerating included *Eucalyptus crebra* and *Corymbia maculata*.

Disturbance present at rehabilitation site HVOWES2013-01 consisted mainly of weeds, and grazing by macropods. No evidence of fire was observed in the rehabilitation area. No areas containing rubbish were observed.

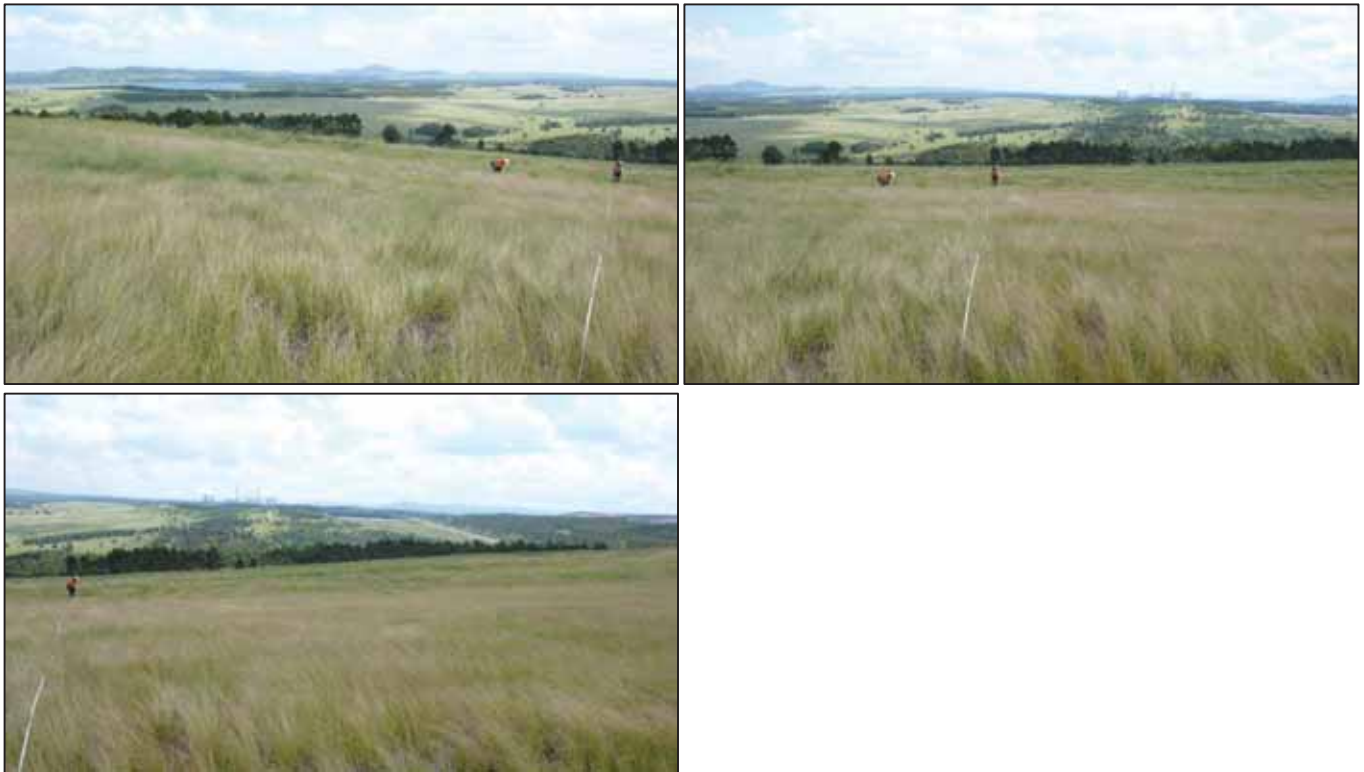
### Start position

Disturbance present at rehabilitation site HVOWES2013-02 consisted mainly of weeds, and grazing by macropods. No evidence of fire was observed in rehabilitation area. No areas containing rubbish were observed.

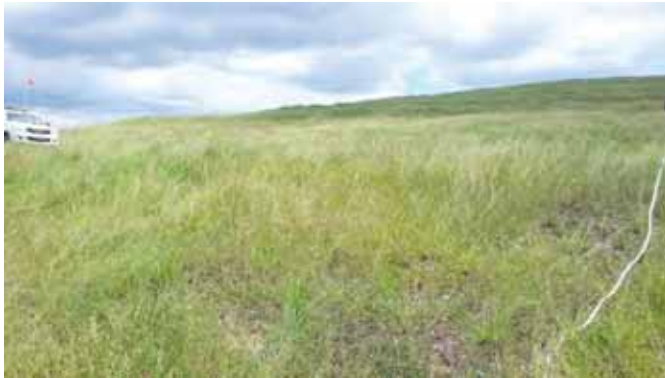
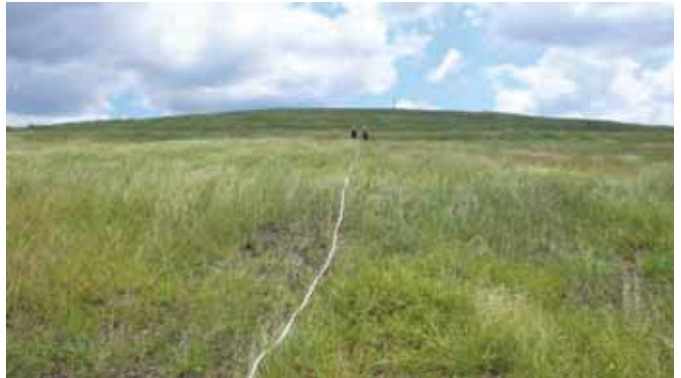
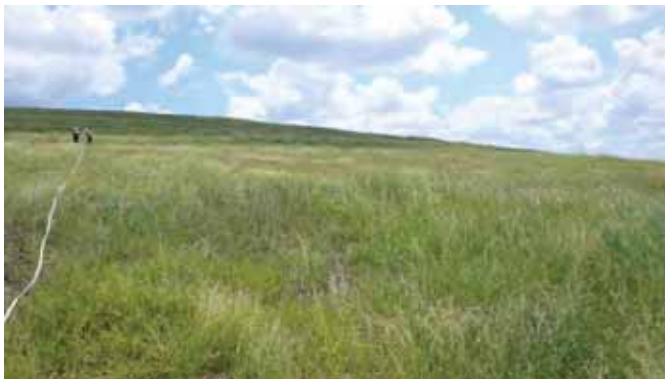
Start position

Disturbance present at rehabilitation site HVOCAR2014-01 consisted mainly of weeds, and grazing by macropods. No evidence of fire was observed in rehabilitation area. No areas containing rubbish were observed.

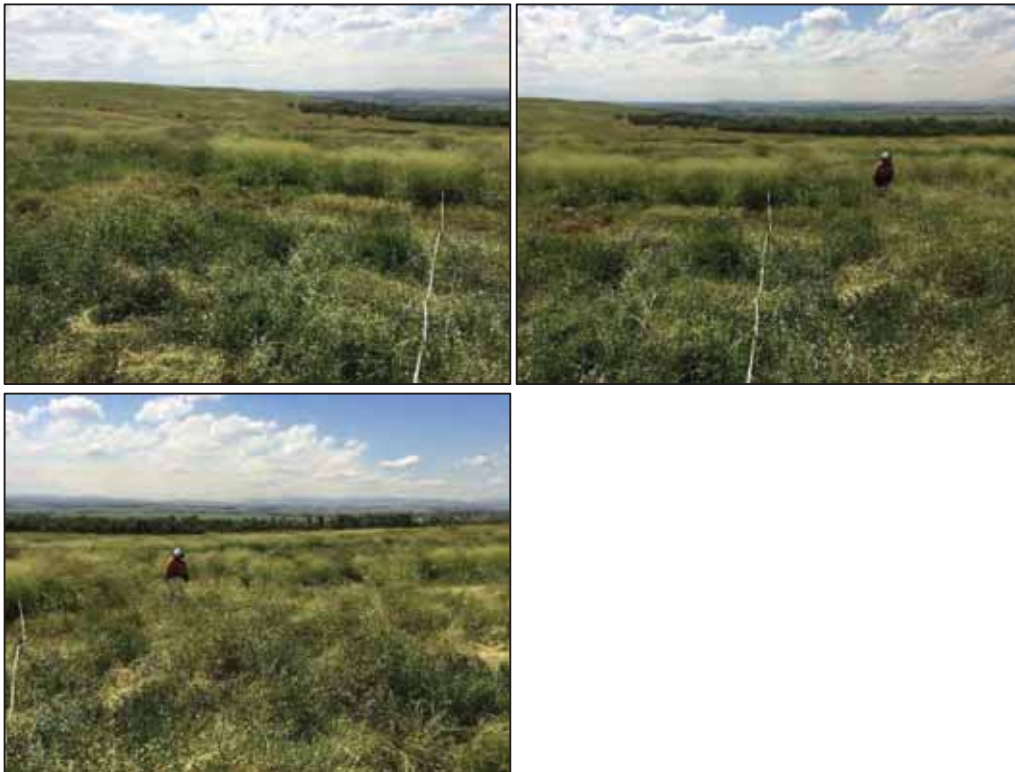
### Start position

Disturbance present at rehabilitation site HVOCHE2012-01 consisted mainly of weeds, and grazing by macropods. No evidence of fire was observed in the rehabilitation area. No areas containing rubbish were observed.

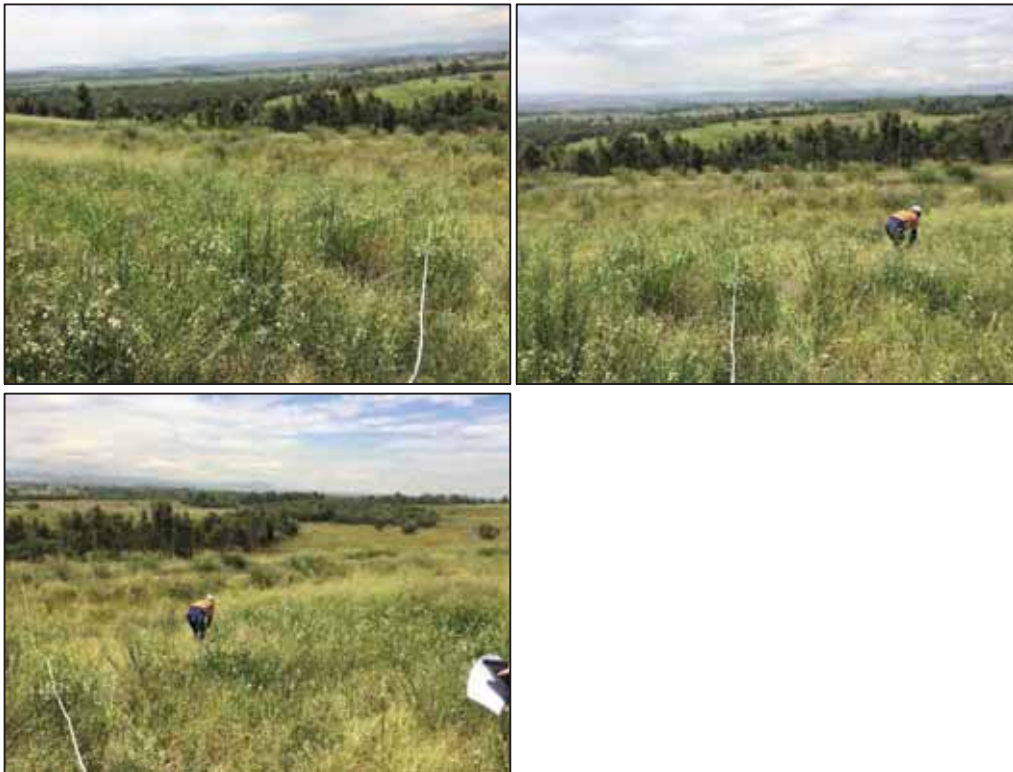
### Start position

Disturbance present at rehabilitation site HVOCHE2013-01 consisted mainly of weeds, and grazing by macropods. No evidence of fire was observed in the rehabilitation area. No areas containing rubbish were observed.

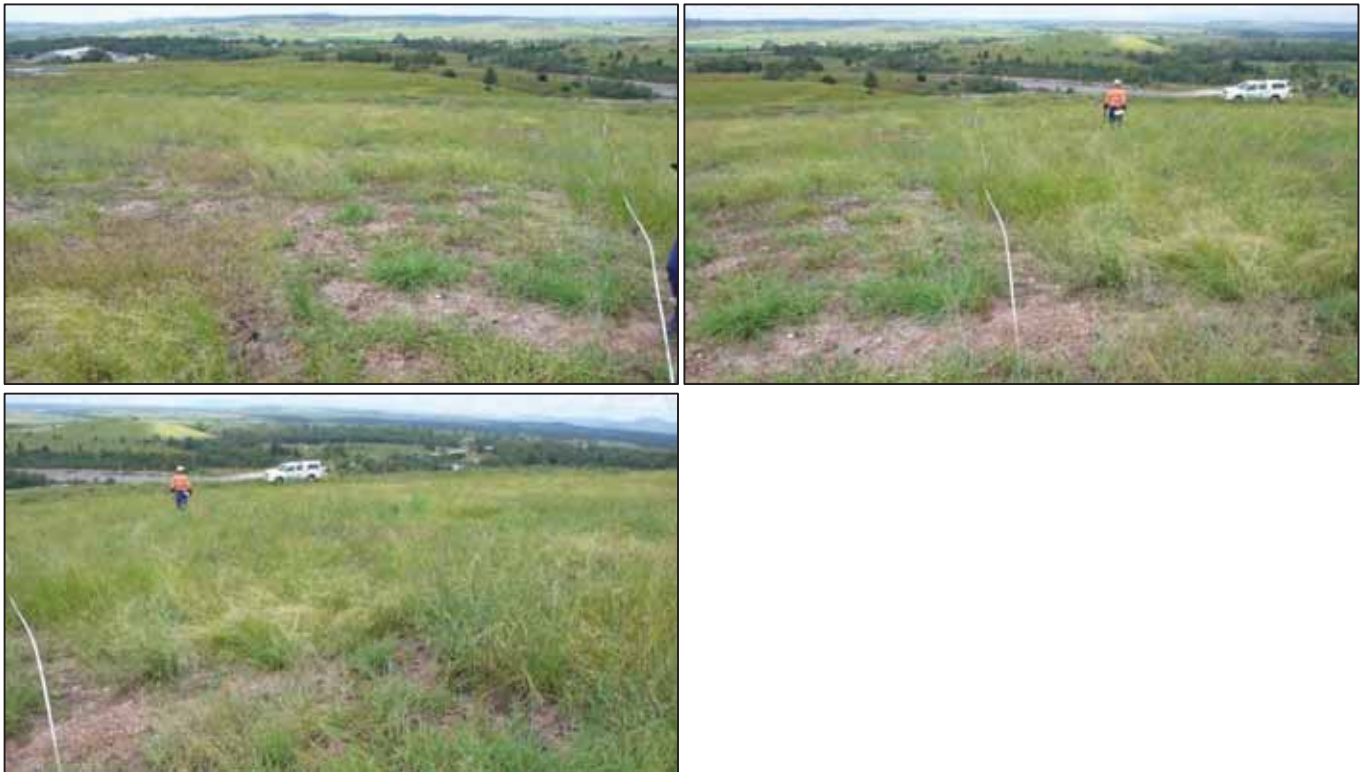
### Start position

Disturbance present at rehabilitation site HVOCHE2014-01 consisted mainly of weeds, and grazing by macropods. No evidence of fire was observed in the rehabilitation area. No areas containing rubbish were observed.

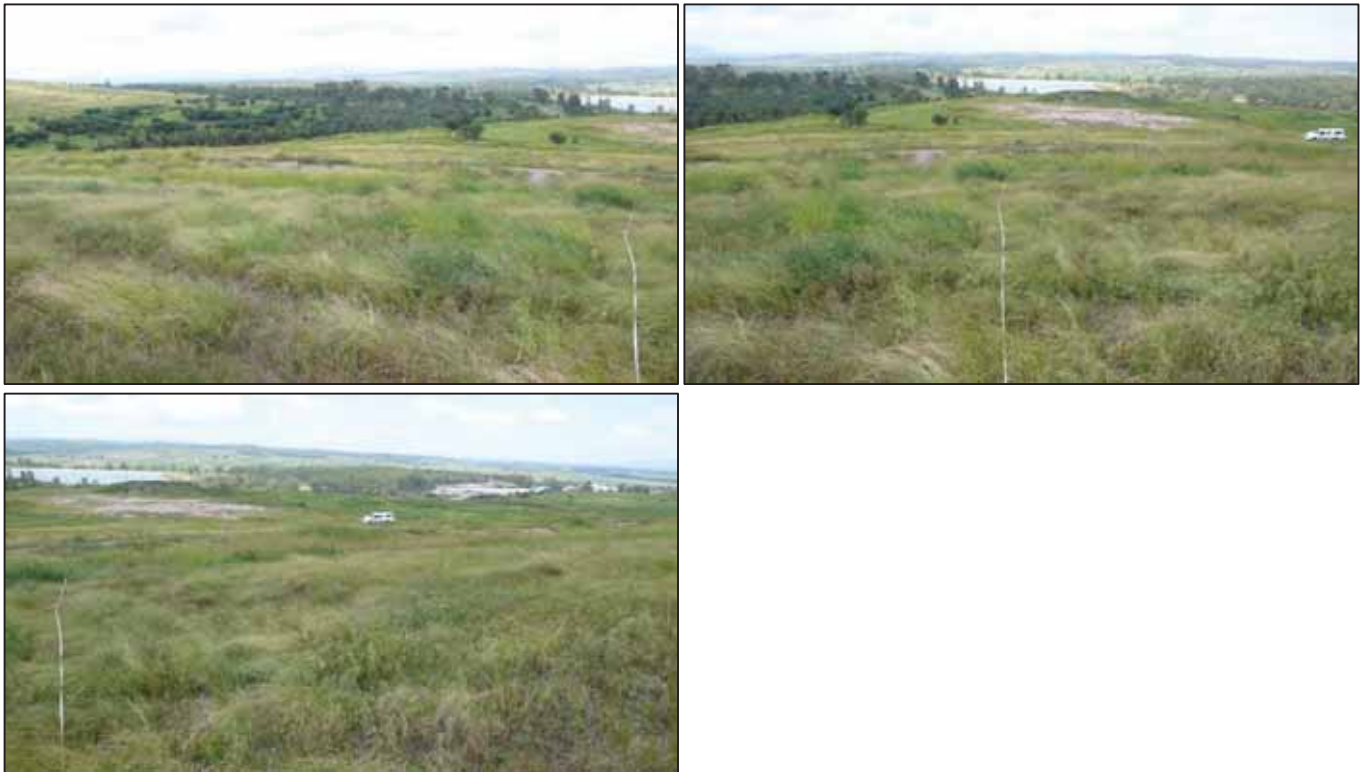
### Start position

Disturbance present at rehabilitation site HVOCHE2012-03 consisted mainly of weeds, and grazing by macropods. No evidence of fire was observed in the rehabilitation area. No areas containing rubbish were observed.

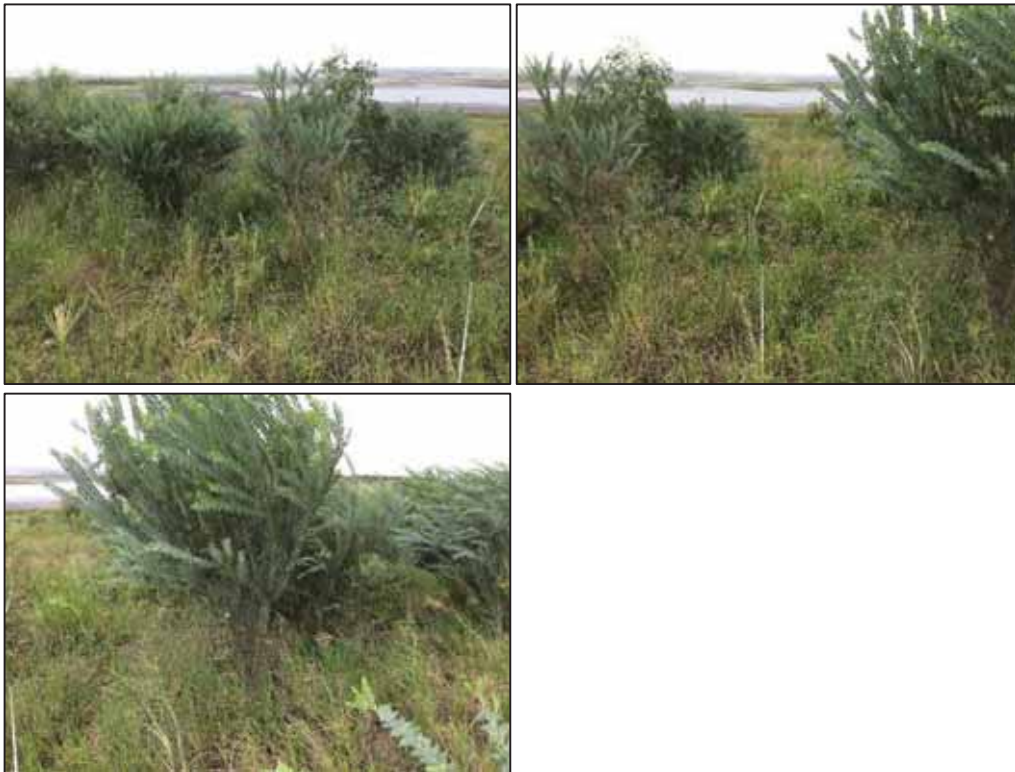
Start position

Disturbance present at rehabilitation site MTWNP2011-01 consisted mainly of weeds, and grazing by macropods. No evidence of fire was observed in the rehabilitation area. No areas containing rubbish were observed.

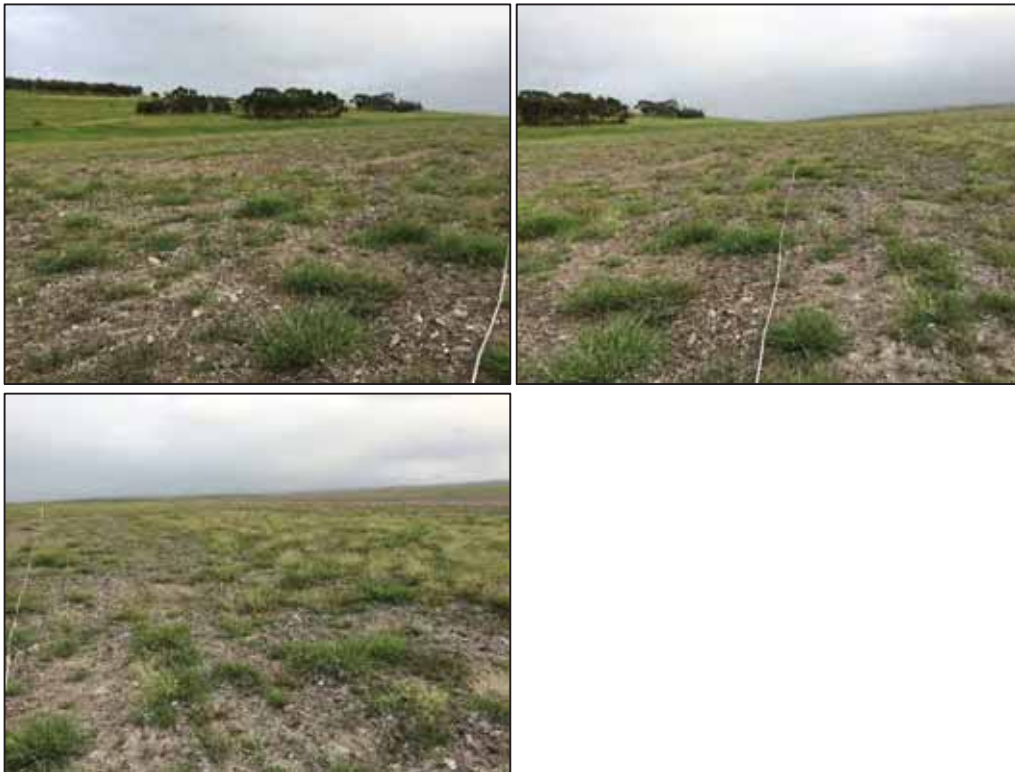
### Start position

Disturbance present at rehabilitation site MTWTDI2015-01 consisted mainly of weeds, and grazing by macropods. No evidence of fire was observed in the rehabilitation area. No areas containing rubbish were observed.

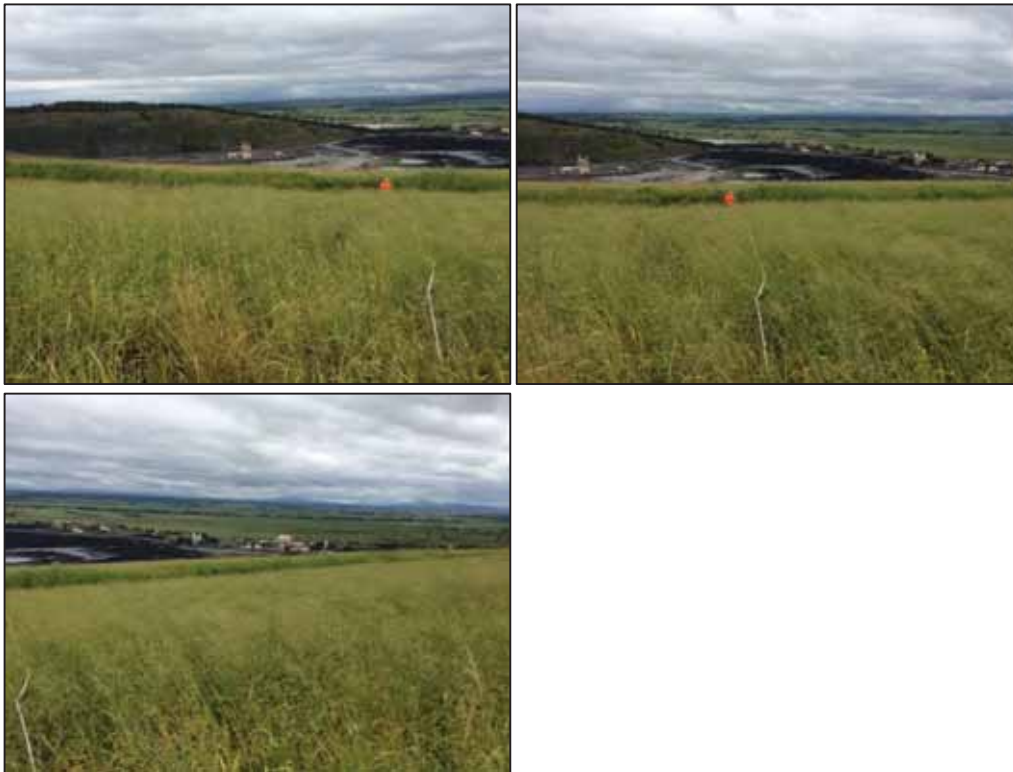
### Start position

Disturbance present at rehabilitation site MTWSPN2014-01 consisted mainly of weeds, and grazing by macropods. No evidence of fire was observed in the rehabilitation area. No areas containing rubbish were observed.

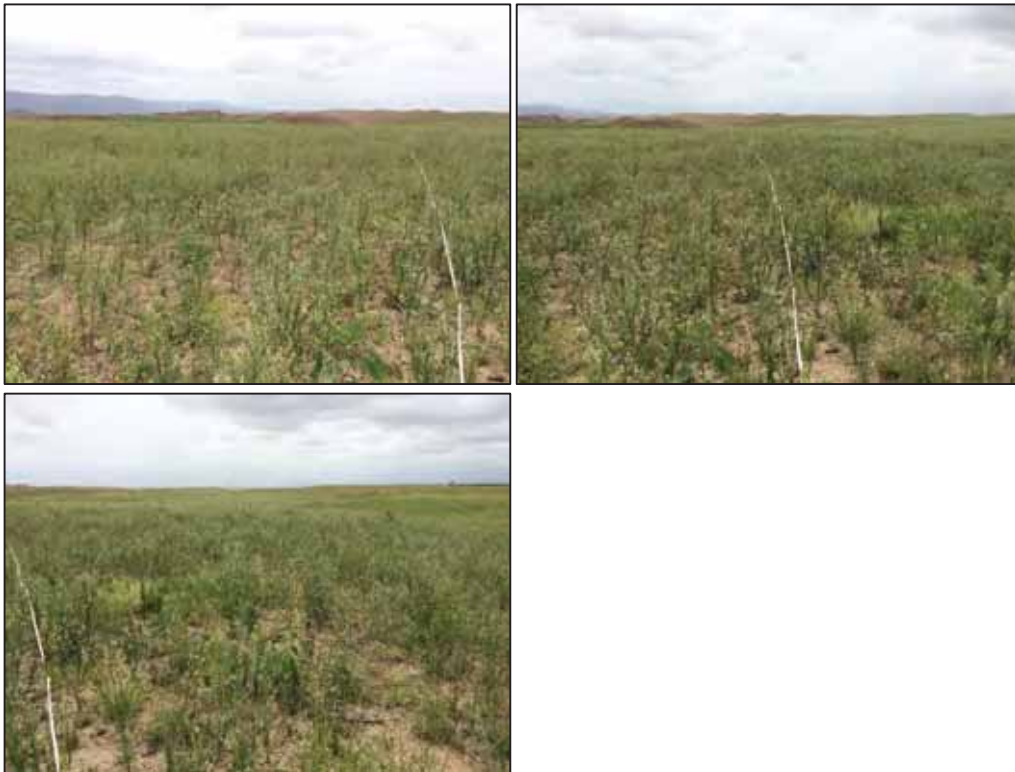
### Start position

Disturbance present at rehabilitation site MTWNP2014-01 consisted mainly of weeds, and grazing by macropods. No evidence of fire was observed in the rehabilitation area. No areas containing rubbish were observed.

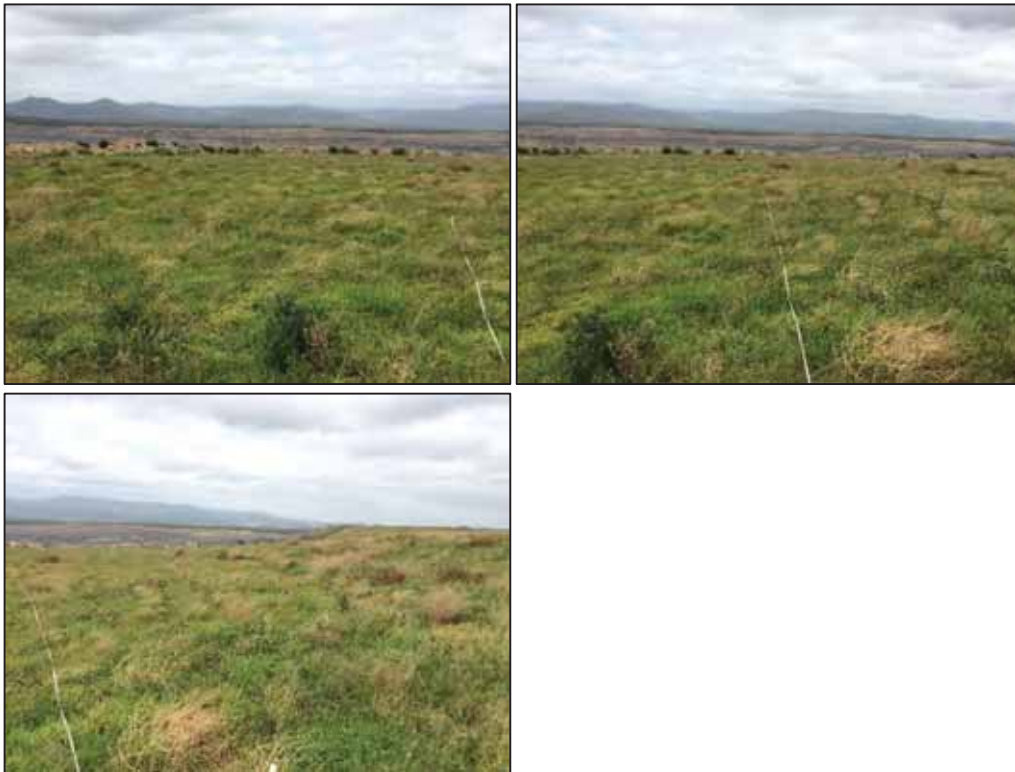
### Start position

Disturbance present at rehabilitation site MTWNP2014-03 consisted mainly of weeds, and grazing by macropods. No evidence of fire was observed in the rehabilitation area. No areas containing rubbish were observed.

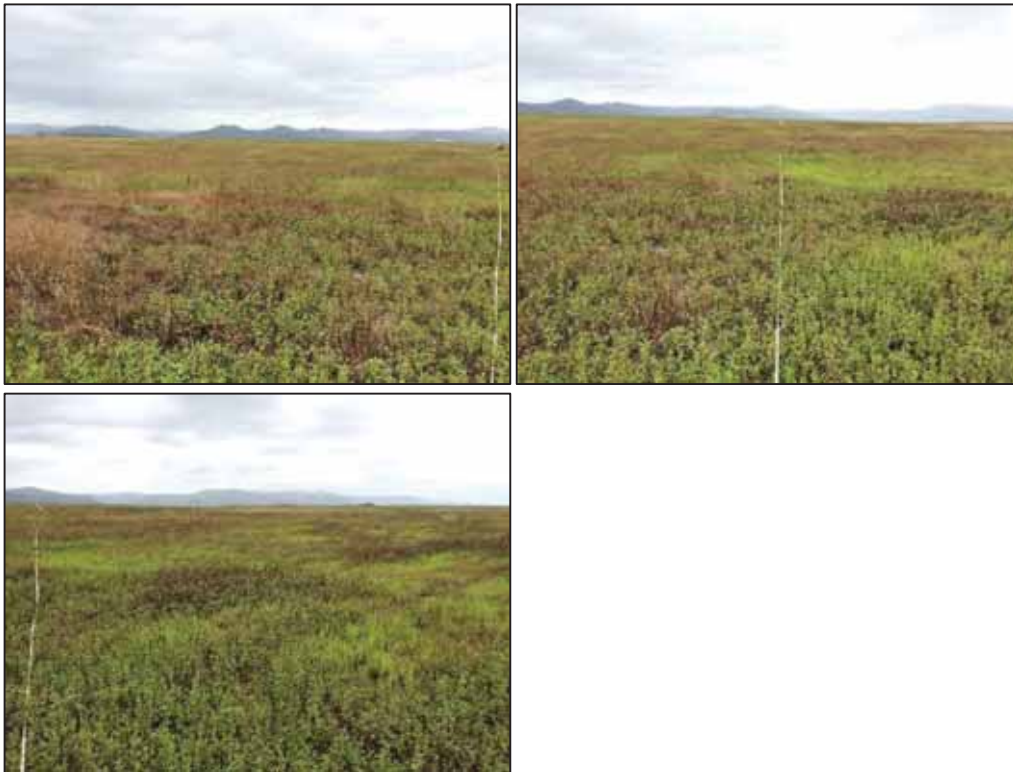
### Start position

Disturbance present at rehabilitation site MTWNP2013-01 consisted mainly of weeds, and grazing by macropods. No evidence of fire was observed in the rehabilitation area. No areas containing rubbish were observed.

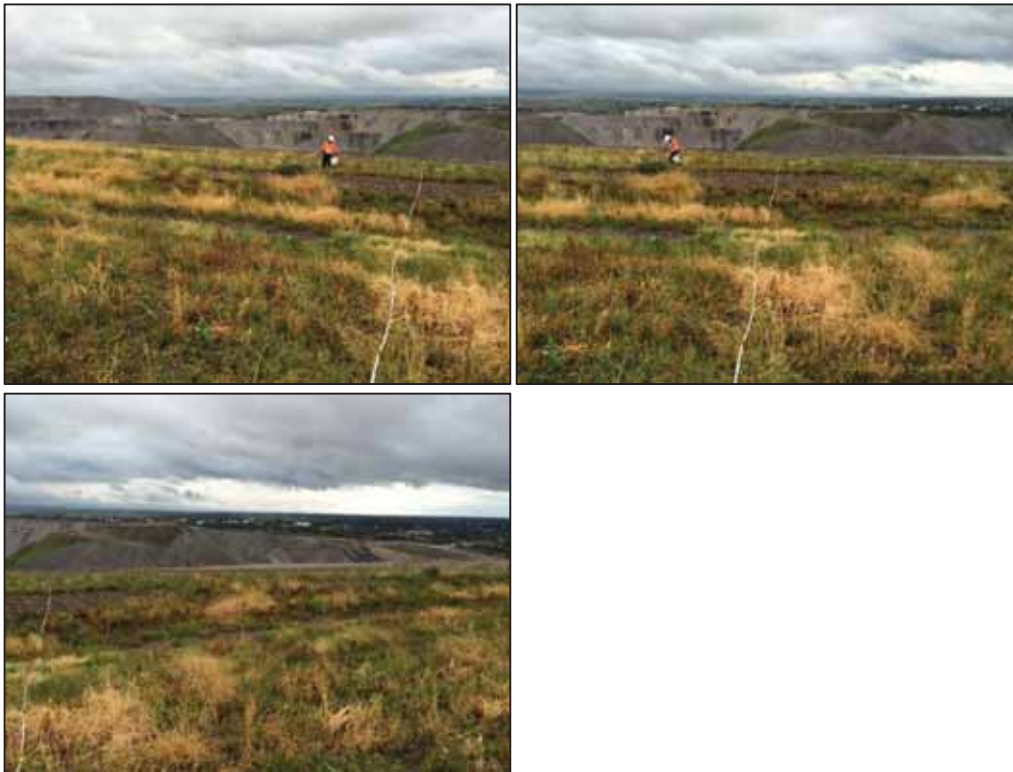
### Start position

Disturbance present at rehabilitation site MTWWDL2014-01 consisted mainly of weeds, and grazing by macropods. No evidence of fire was observed in the rehabilitation area. No areas containing rubbish were observed.

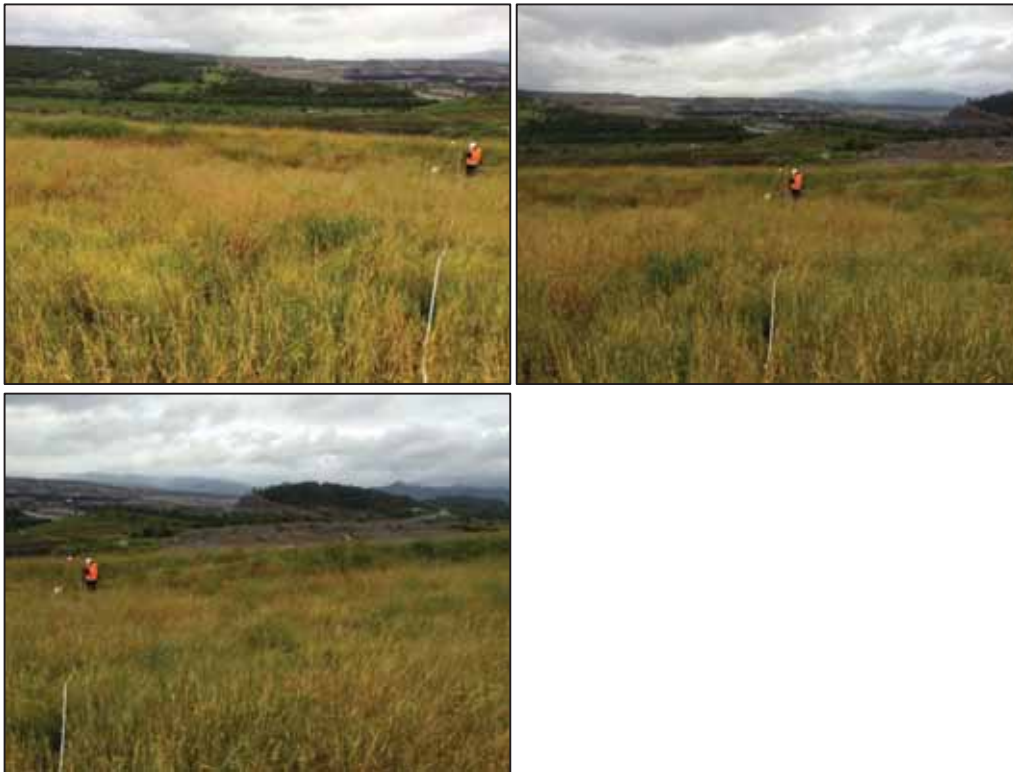
### Start position

Disturbance present at rehabilitation site MTWWDL2014-02 consisted mainly of weeds, and grazing by macropods. No evidence of fire was observed in the rehabilitation area. No areas containing rubbish were observed.

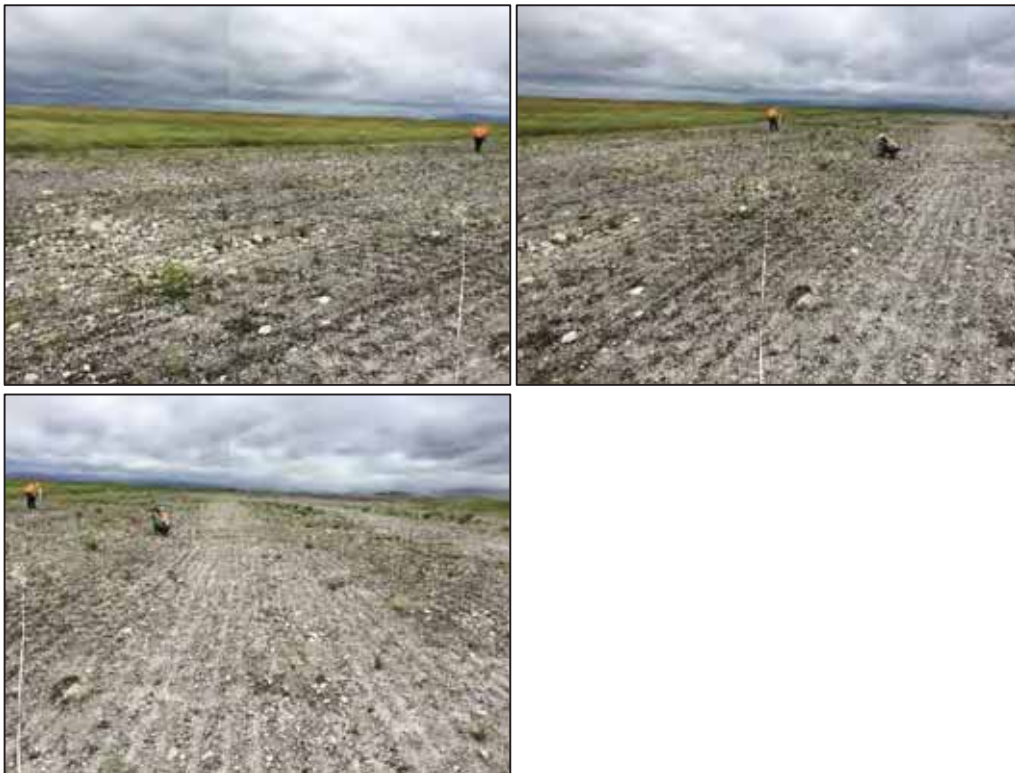
### Start position

MTWCDD2015-01 rehabilitation area occurs on a combination of spoil and compost at Mount Thorley-Warkworth. The rehabilitation site was dominated by the following introduced species: *Conyza bonariensis*, *Chloris gayana*, *Echinochloa crus-gali*, *Senecio madagascariensis*, *Solanum nigrum* and *Panicum maximum*. Native species included *Eriochloa pseudoastritrica*, *Austrodanthonia spp.*, *Einadia nutans*, *Austrostipa scabra*, *Bothriochloa macra* and *Chloris truncata*.

It should be noted that a number of Eucalypts were regenerating in the area. Most of these are likely *Eucalyptus crebra* due to their narrow leaves.

Disturbance present at rehabilitation site MTWCDD2015-01 consisted mainly of weeds, and grazing by macropods. No evidence of fire was observed in the rehabilitation area. No areas containing rubbish were observed.
